Independent Observer summary report on *MV Yangtze Fortune*

Cattle exported to China in November 2019

Report 201, April 2020

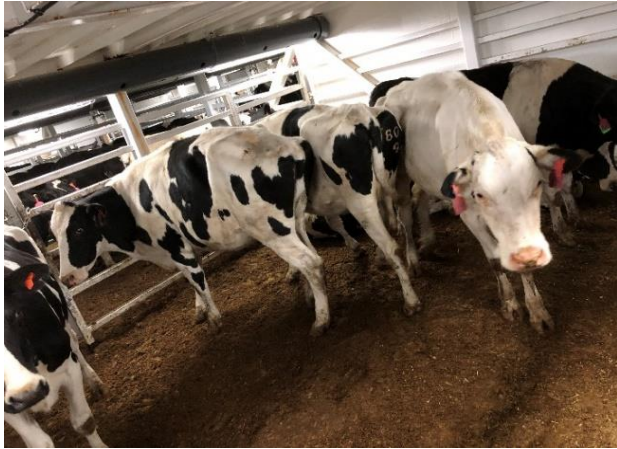
Day 2 - Dairy heifers in pen. No issues identified

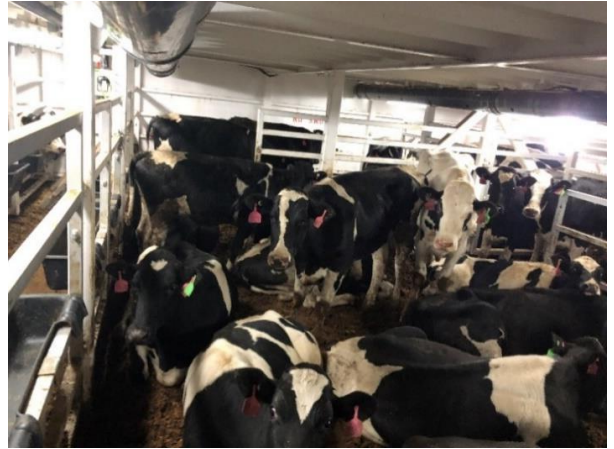
Day 4 - Cattle in pen. No issues identified

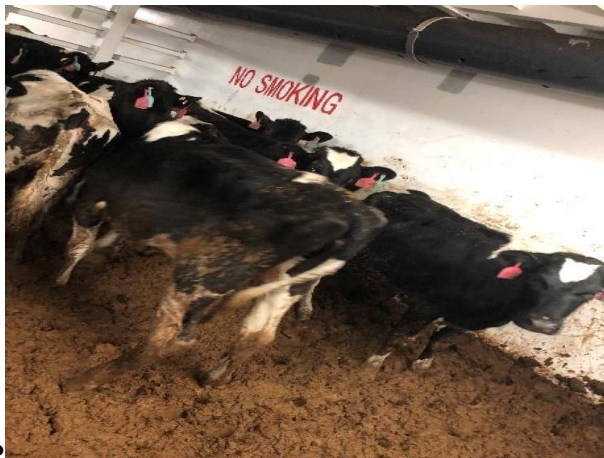
Deck washing was performed on days 9, 10, 13 and 14. The observer noted that the on-board AAV had an active role in wash-downs, requesting additional washing, for excess water to be sponged up and for additional sawdust to be laid. All cattle settled well after wash-down and pen conditions improved. Pad conditions became deeper and sloppier as humidity increased, however no negative health or welfare implications were observed upon the cattle within affected pens.

Day 9 – Cattle in pen prior to wash-down

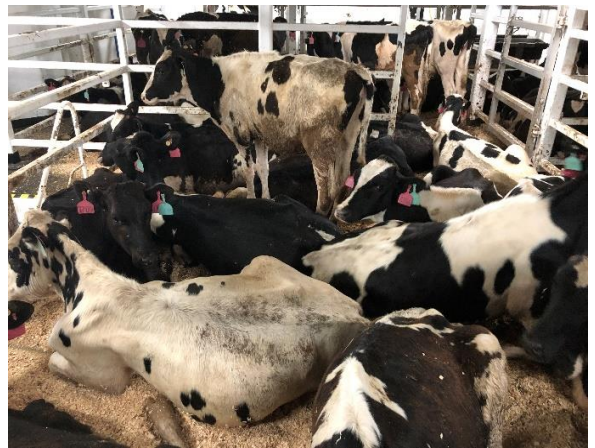
Day 10 - Cattle in pens after wash-down. No issues identified.

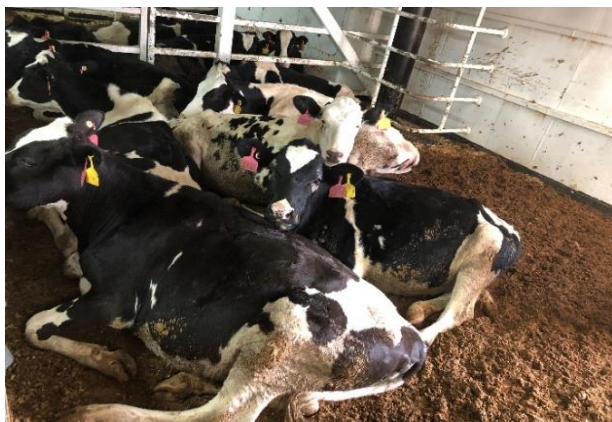
Day 15 – Cattle in pens during discharge. No issues identified

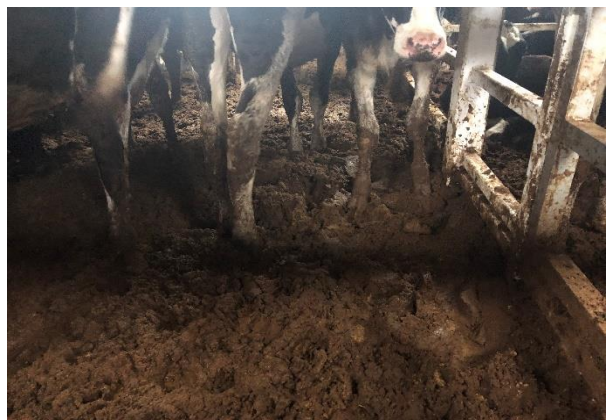
Day 7 – Demonstrating pad conditions
