Independent Observer summary report on *MV Yangtze Harmony*

Cattle exported to Vietnam in February 2020

Report 215, July 2020

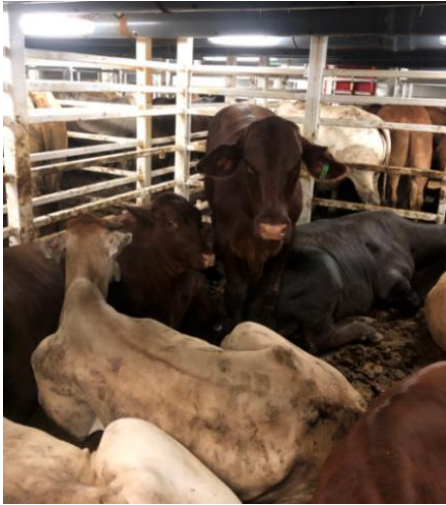
Day 2 Cattle in pen—no issues identified.

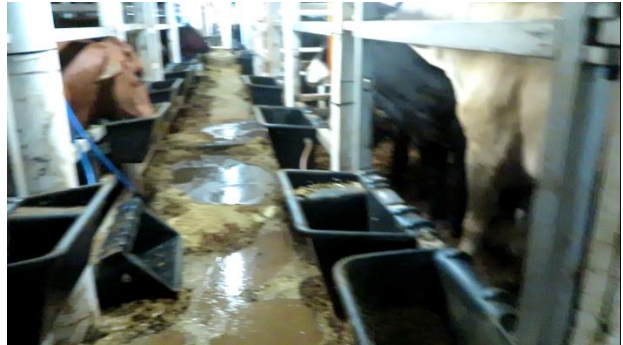
Water was generated by two reverse osmosis systems and stored in tanks. Delivery of water to troughs was automated by a float-valve mechanism and was observed to be free of contaminants, and to flow at an acceptable rate. Water troughs were observed to frequently be knocked off rails by cattle, resulting in isolated flood events. The observer reported that this was addressed acceptably by crew and stockpersons throughout the voyage and water remained available to cattle *ad lib*.

Day 4—Water troughs knocked off in aisle. Subsequently resolved by crew.

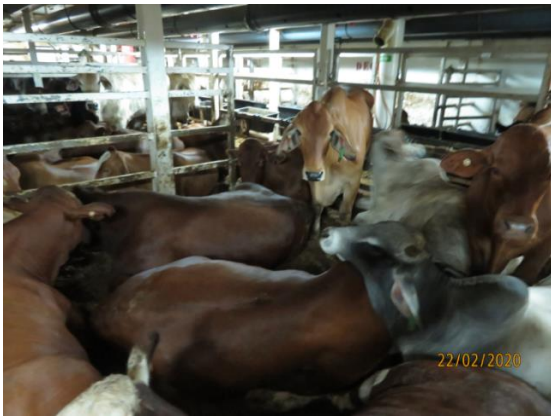
Day 4 Cattle in pen—no issues identified

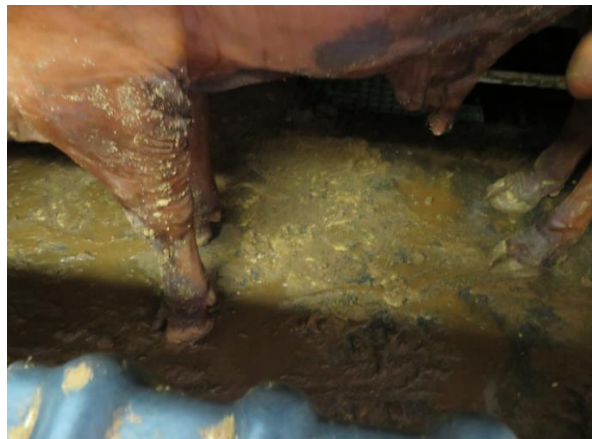
deck washing and pad maintenance was effective in improving pad conditions and no negative impact was observed on the cattle's health due to the isolated flood events.

Day 8 Cattle pad conditions post wash-down—no issues identified

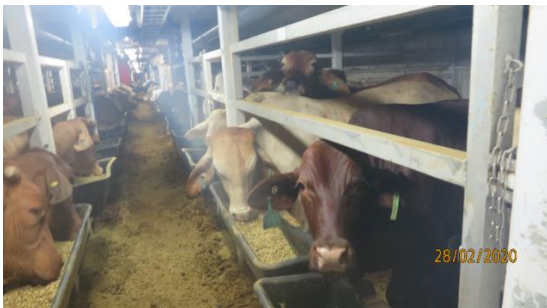
Day 10 Cattle feeding—no issues identified

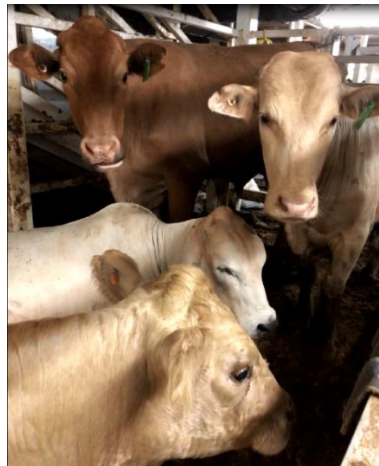
Day 11 Cattle in pen—no issues identified
