REPORT ON MV (YANGTZE FORTUNE) VOYAGE (No.1804) Maiden voyage was on the 04/10/2017

LOAD PORT: Fremantle Western Australia

TO: DISCHARGE PORT(S) Oman Muscat

Veterinary Officer, Department of Agriculture and Water Resources

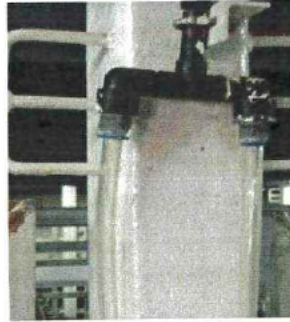
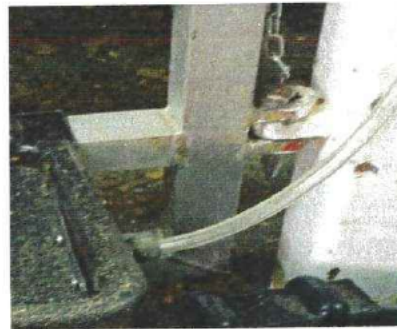
The watering system is shown in the attached photographs. There were some issues with connections especially when crew had to change troughs from cattle height to sheep height. There was always maintenance that was required for leaks and hoses disconnecting from some of the troughs.

Watering system good until red tap then a lot of maintenance.

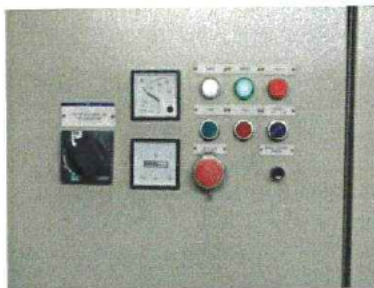
Controls panels found on deck 4

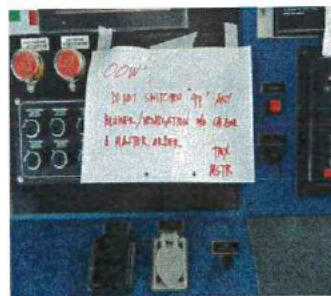
Controls on the Bridge

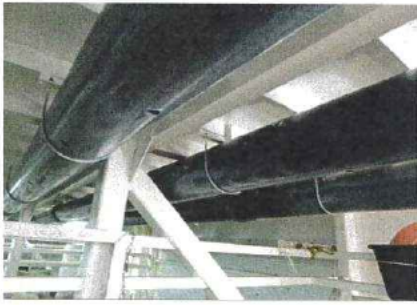
Ventilation system in pens

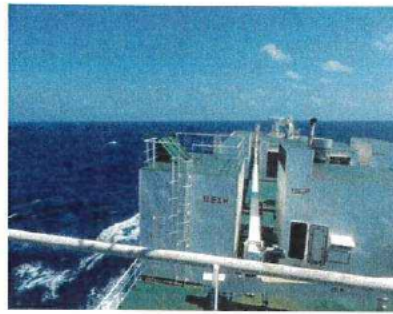
Figure 1 Exhaust system 9 EXH 1 SUP is related to airflow in to ventilation system

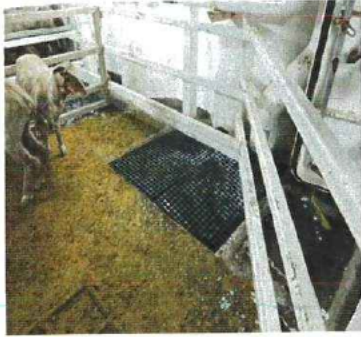
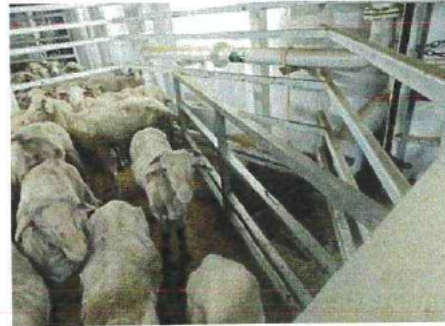
With regards to pens there is one pen on deck 1 (pen 32) approved by AMSA to hold animals. Crew had to put up extra gate to protect animals from falling down grates. See attached photos;

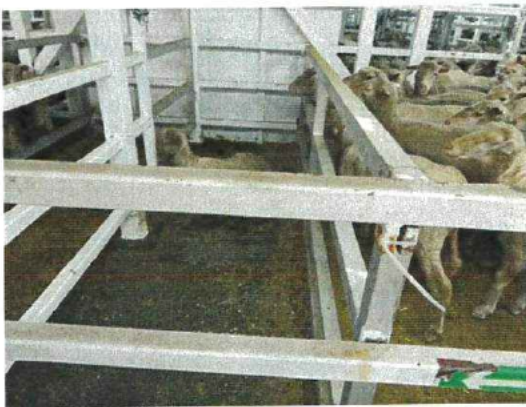
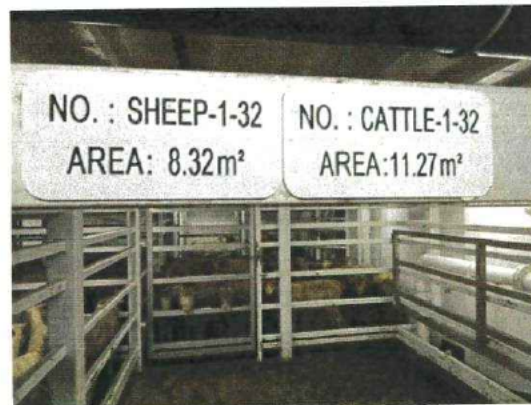
Another observation to note with regards to AMSA requirement. The pens that have a cattle and sheep different square meterage, AMSA requires the divider gates to be put up, but as soon as at sea these are all removed to allow extra space and also animals tend to jump through and get caught in this area. (See Photographs)

The animals took a lot longer to settle due to disruptions in pens taking these gates down.

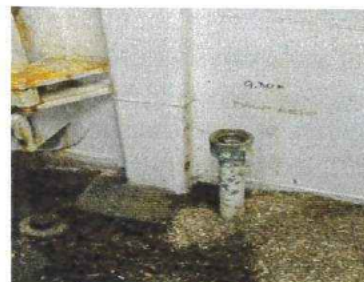
Measuring water tanks on daily basis in tanks

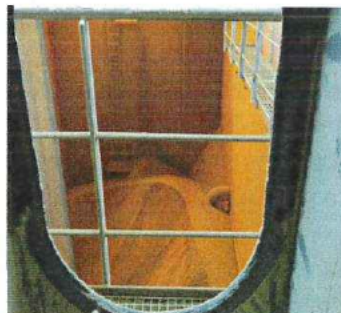
Fodder tank

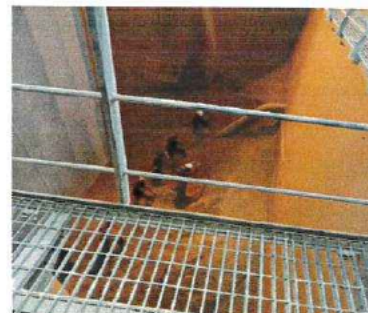
Crew having to get into fodder tanks to push fodder to conveyor belt
