# Independent Observer summary report on MV Rahmeh (Gulf Livestock 1)

## Cattle exported to China in April 2019

Report 109, October 2019

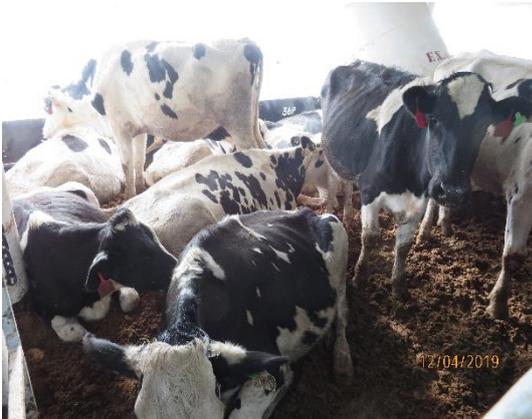
Day 5 Cattle in pen no issues identified

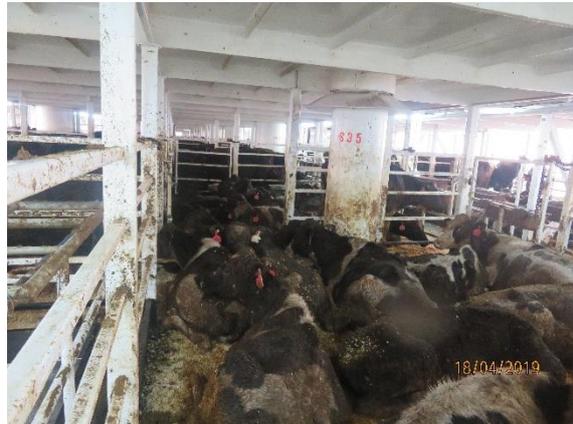
Day 11 Cattle in pen – after deck wash

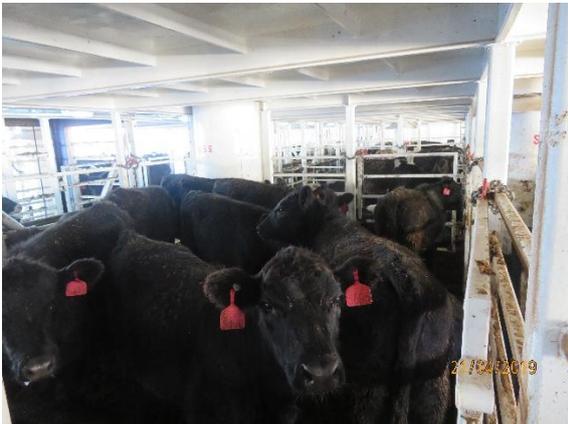
Day 14 Cattle in pen - no issues identified

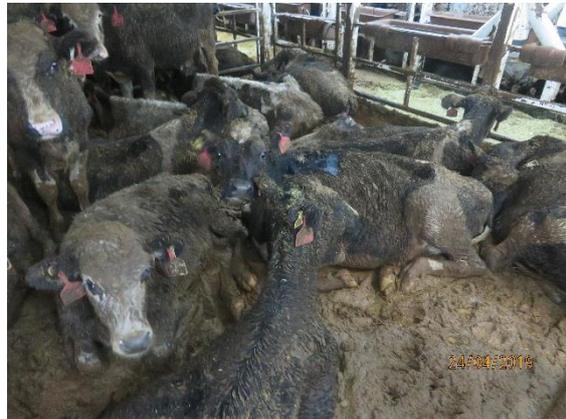
Day 17 Cattle in pen - before deck wash

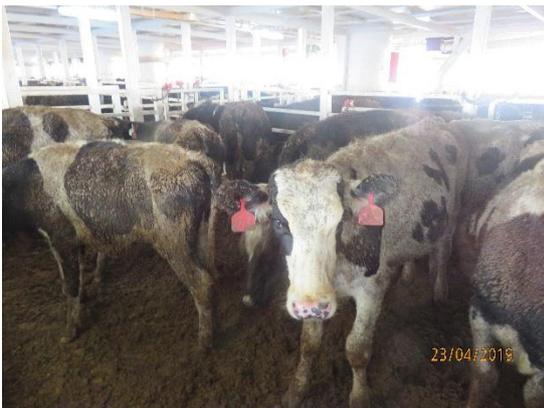
Day 16 Cattle in pen – no issues identified

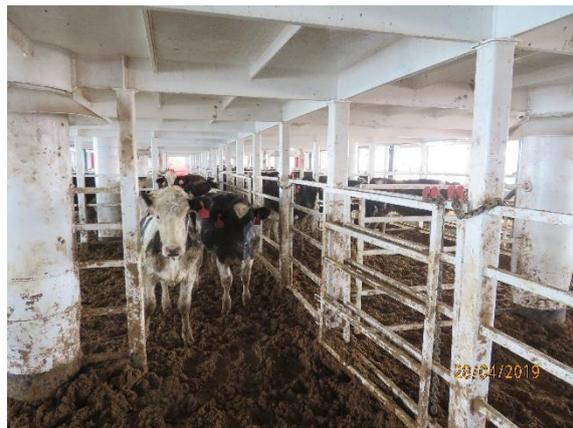
Day 21 Cattle unloading – no issues identified
