Independent Observer summary report on MV *Yangtze Fortune*

Cattle exported to China in April 2019

Report 111, December 2019

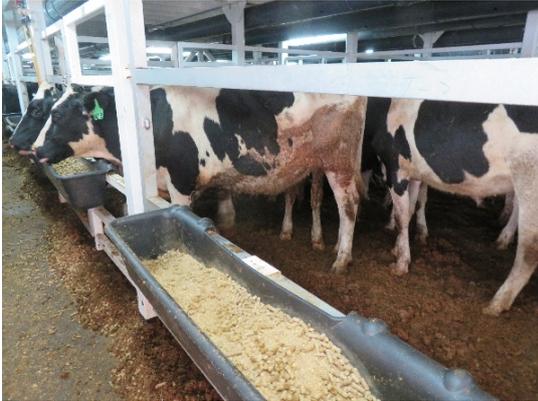
Day 4 Cattle in pen—no issues identified

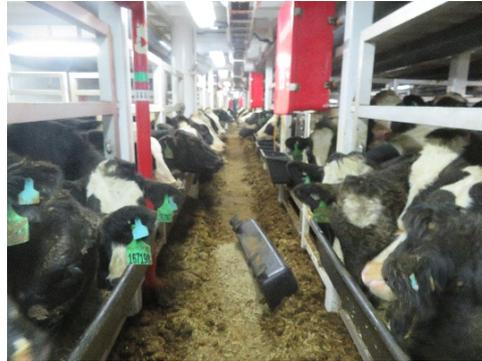
The observer noted that a number of instances where feed troughs were knocked off the pen's rails, restricting access to feed during that feed period. However, the crew were observed picking up dislodged troughs and regularly maintaining feeds throughout the day and night.

Water was available ad lib, except when troughs were knocked off the pen rails. In these instances the crew responded quickly and water was restored to the pens as per the ASEL requirements. Cleaning of faecal material from the troughs was regularly undertaken by the crew, including night watch crew, working between feeding times to complete this task.

Day 6 Cattle in pen—trough knocked off rail

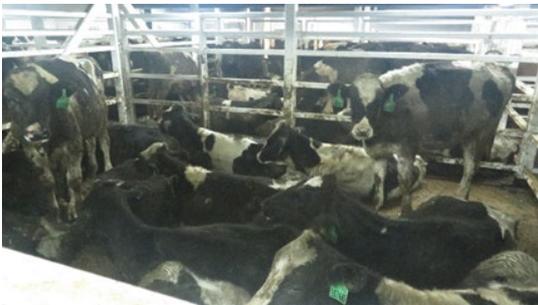
Day 9 Cattle in pen—no issues identified

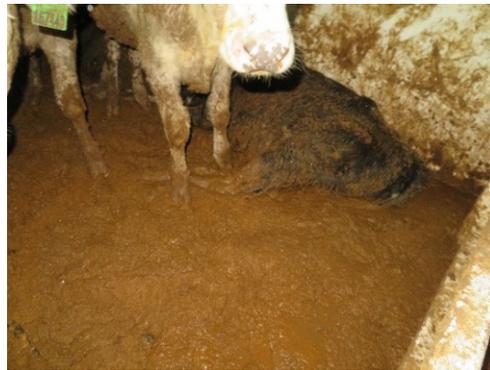
Pen conditions deteriorated markedly after the first deck washout on days 8 and 9 and lasted until the second wash out on days 14 and 15. The observer commented that faulty water pipes

and water troughs, poor pen drainage, and the humid conditions were considered to be the major contributors to poor pen conditions. Drainage of excess fluid through bilge pumps and addition of sawdust were undertaken to improve conditions, however, these actions had limited effect. The pad conditions improved significantly after the second deck washout. The prolonged liquid pad conditions caused lameness in a significant number of animals.

Day 12 Cattle in pen— wet pad condition

Since this voyage, the exporter has been required to implement a pad condition management plan as part of their Approved Arrangement. The department will continue to assess the effectiveness of these actions.

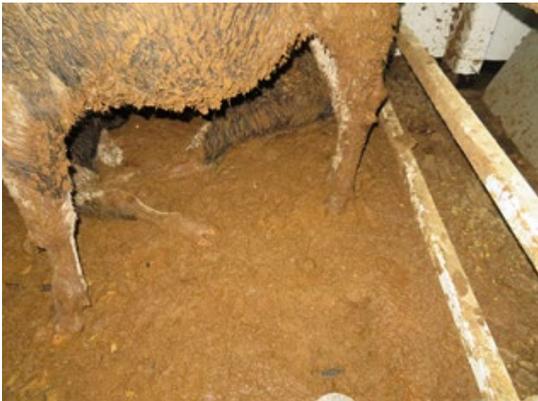
Day 15 Cattle in pen— wet pad condition

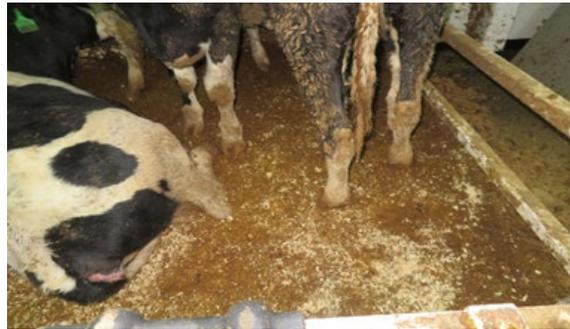
Day 18 Cattle in pen—no issues identified
