Independent Observer summary report on MV *Girolando Express*

Cattle exported to Indonesia in July 2019

Report 153, December 2019

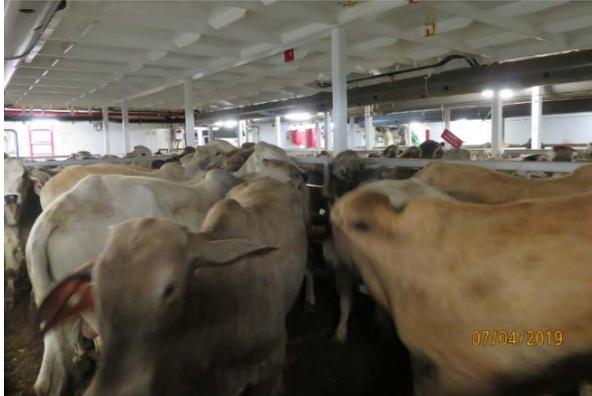
Day 1 Cattle in pen – no issues identified

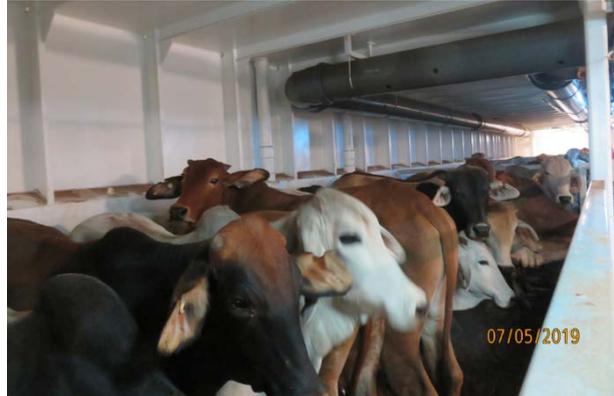
Day 2 Cattle in pen – no issues identified

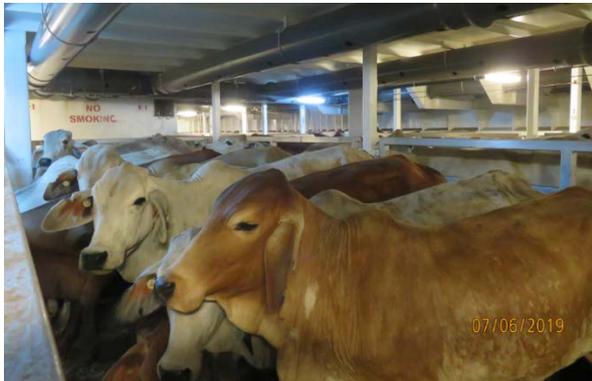
Day 3 Cattle in pen – no issues identified

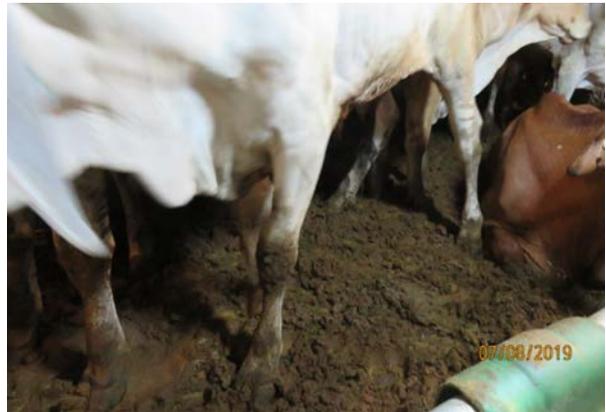
Day 5 Pad – no issues identified

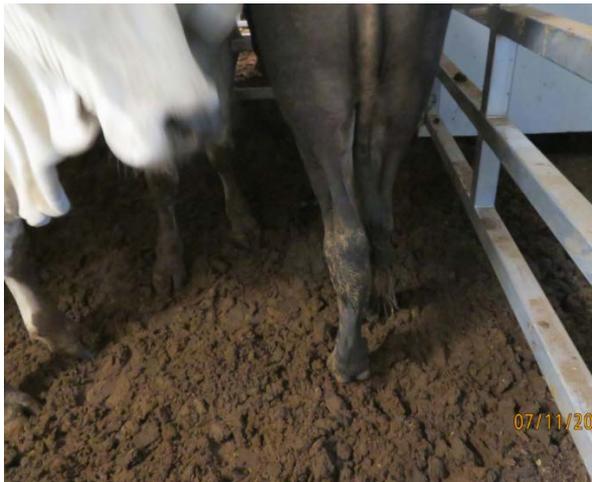
Day 8 Pad – no issues identified

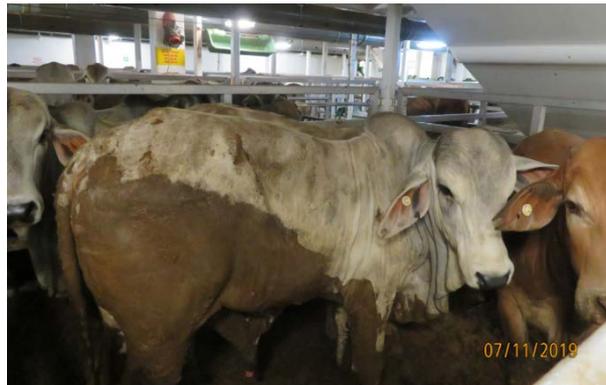
Day 8 Cattle in pen – no issues identified
