Independent Observer summary report on *MV Gelbray Express*

Cattle exported to China in August 2019

Report 166, January 2020

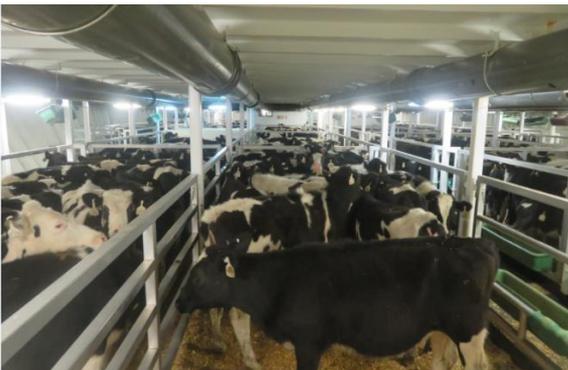
Day 1 Cattle in pen – no issues identified

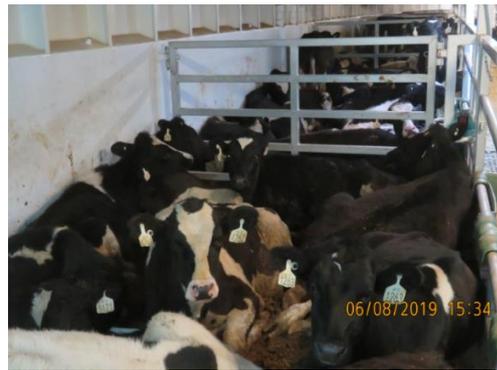
Day 5 Cattle in pen – no issues identified

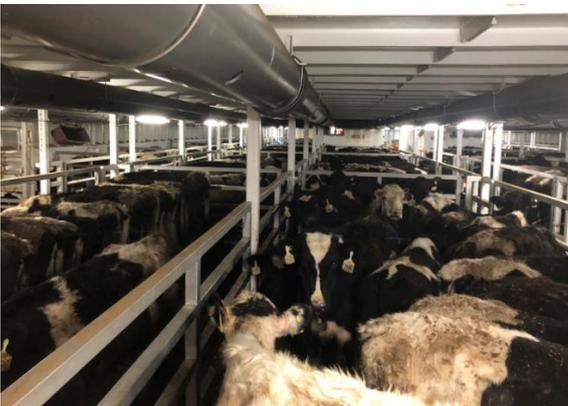
Day 8 Cattle in pen – no issues identified

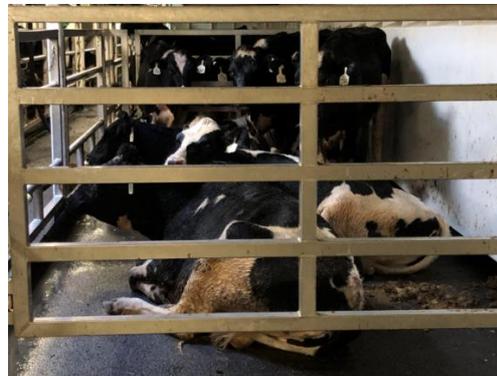
Day 10 immediately after deck wash – no issues identified

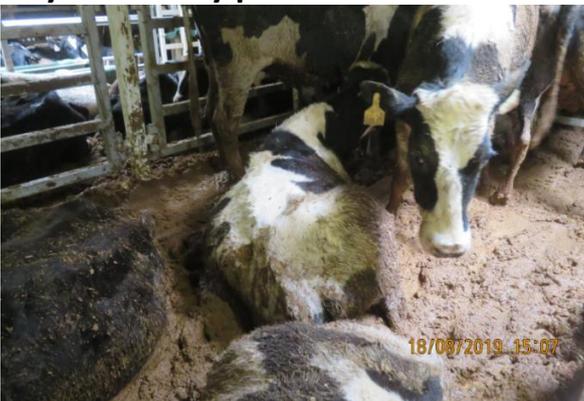
The stockperson made repeated requests to the master to increase ventilation in the cattle decks because of unsatisfactory pad drying. The master agreed to this request after voyage day 12, but then reduced ventilation three days later. Despite these concerns, the stockperson rated ventilation as 'good' in each of their daily reports.

The livestock decks were washed out during the voyage. Following the initial wash, and with the increase in humidity at the equator, the pads did not dry out effectively, which meant that many of the pens were maintained with a slurry of up to 5 cm deep.

Day 16 Muddy pad

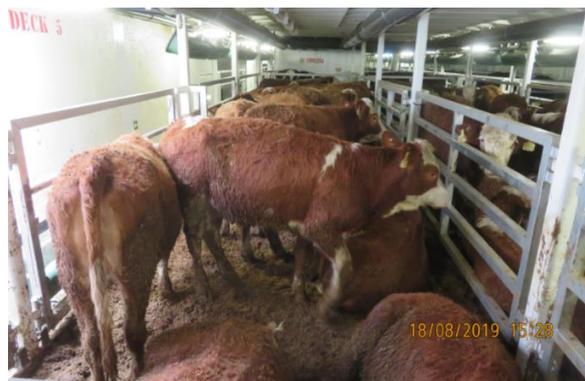
Day 16 Cattle in pen – no issues identified
