Independent Observer summary report on MV *Gloucester Express*

Cattle exported to China in August 2018

Report 17, March 2019

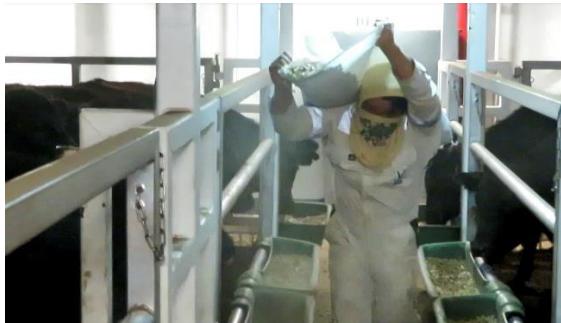
Day 2 Cattle being fed—no issues identified

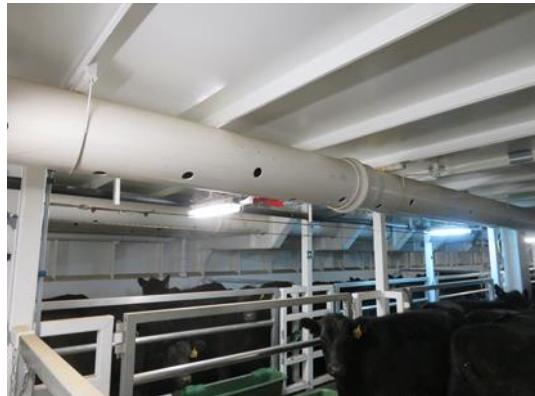
Day 2 Cattle in pen—no issues identified

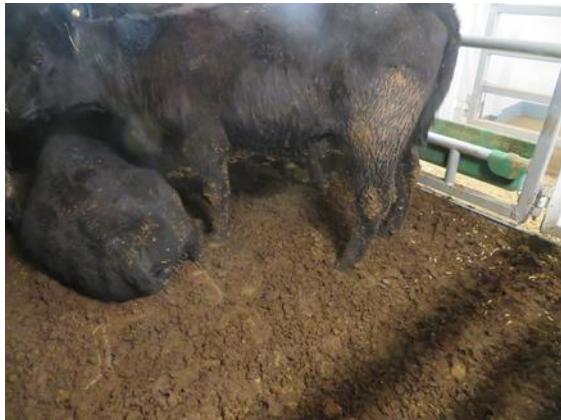
Day 6 Cattle in pen—no issues identified

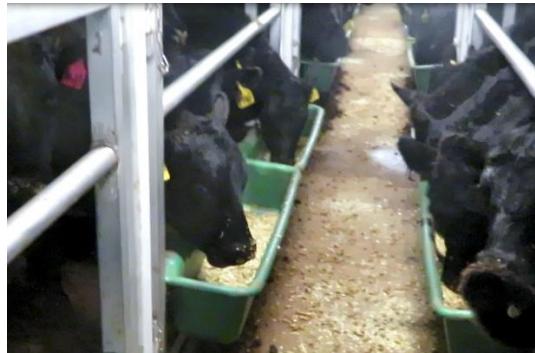
Day 6 Cattle in pen—no issues identified

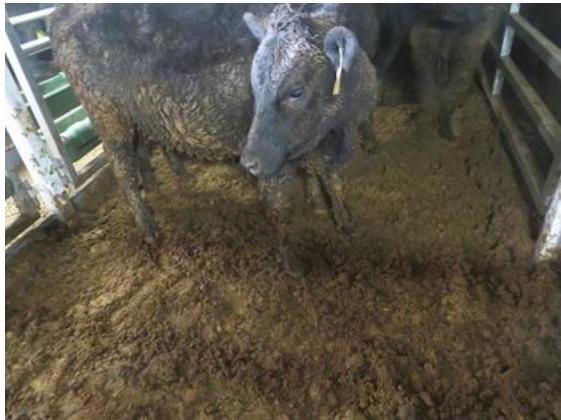
Day 17 Cattle in pen—no issues identified

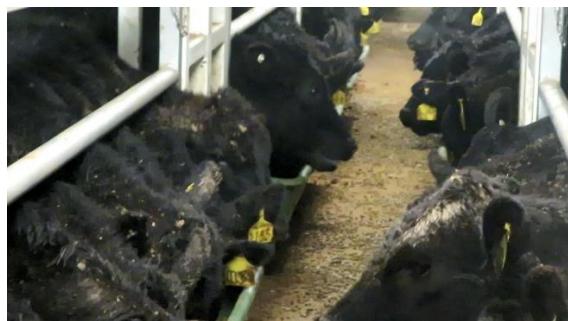
Day 18 Cattle being fed—no issues identified
