Independent Observer summary report on *MV Ocean Ute*

Cattle exported to China in September 2019

Report 182, February 2020

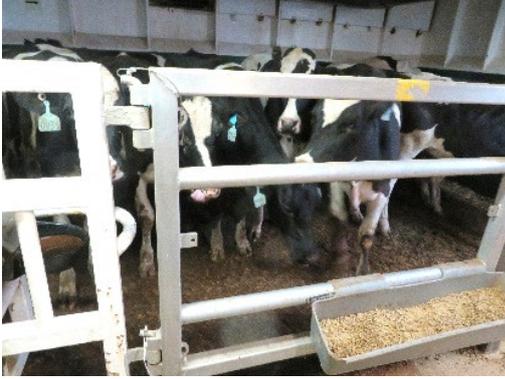
Day 1 Cattle in pen—no issues identified

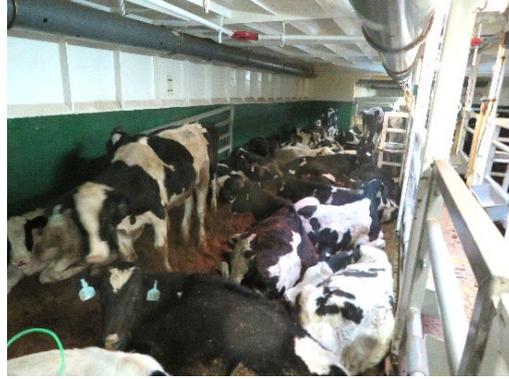
Day 5 Cattle in pen—no issues identified

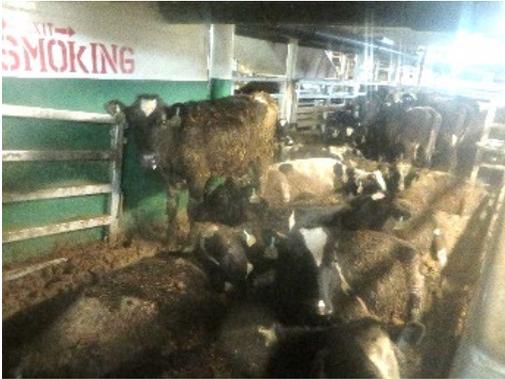
Day 10 Cattle in pen—no issues identified

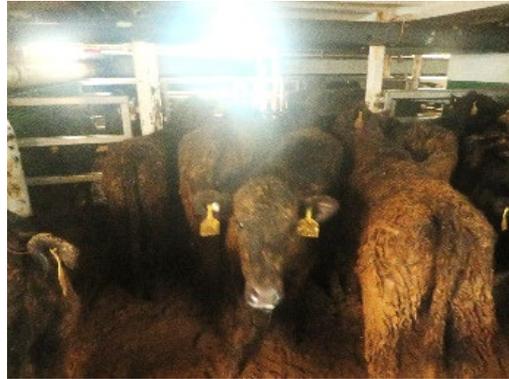
Day 15 Cattle in pen—Deck wash required

The pen stocking density, sufficient space to rest, and access to feed and water were compliant with ASEL. Surplus bedding was loaded for the voyage and pad condition was managed by washing cattle decks. Decks were washed down 3 times during the voyage, with an extra wash on Deck 6. Deck washing was conducted in such a way that no stress indicators were observed for its duration.

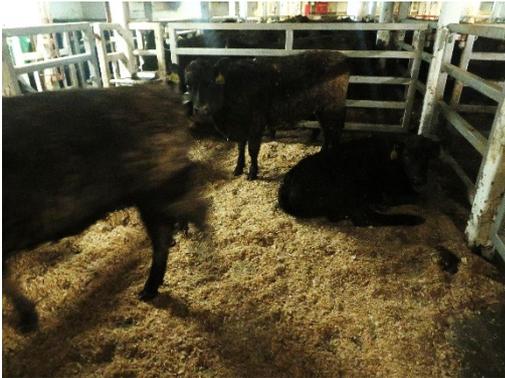
Day 17 Cattle in pen—After deck wash. No issues identified.

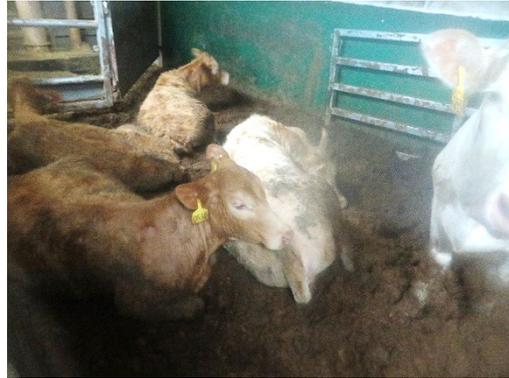
Day 21 Cattle in pen—No issues identified
