Independent Observer summary report on MV *Bahijah*

Cattle exported to Israel in November 2019

Report 202, January 2020

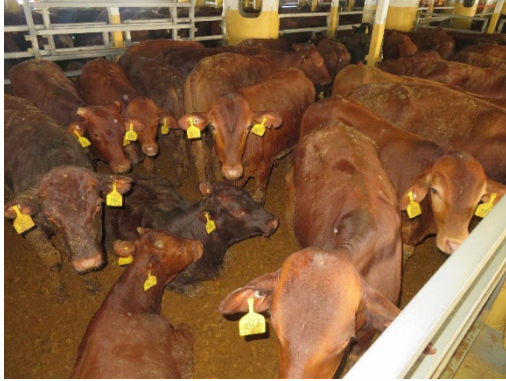
Day 13 Cattle in pen—no issues identified

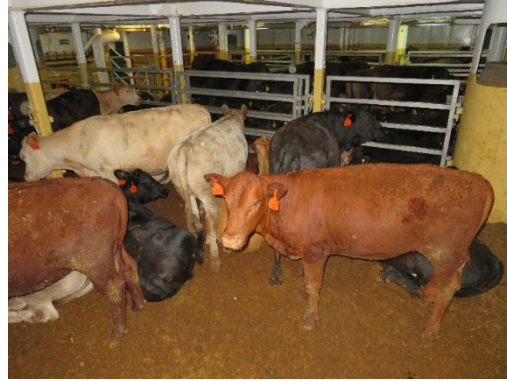
Day 6 Cattle in pen—pad condition prior to wash-down

Deck washing was performed on days 8, 9, 12, 13, 16 and 17. Pen conditions remained firm throughout the voyage, reaching a maximum depth of 10cm in most pens. The observer noted there was sufficient space for greater than 50% of cattle to lie down during the voyage, with adequate access to feed and water at all times.

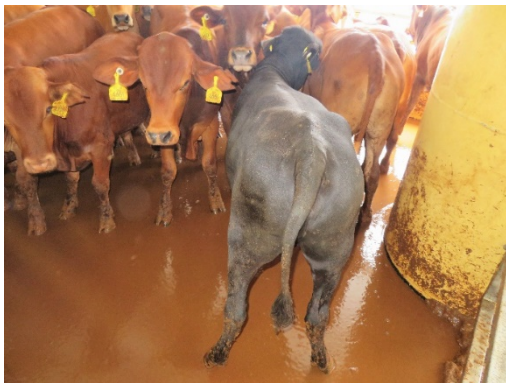
On two occasions during the voyage, inundation with sea water due to poor weather conditions resulted in flooding of several pens on Deck 5. Affected cattle were re-located to empty pens on Deck 7, where they remained until the pens on Deck 5 were dried out and refreshed with new bedding.

Day 3 Flooding—prior to cattle re-location

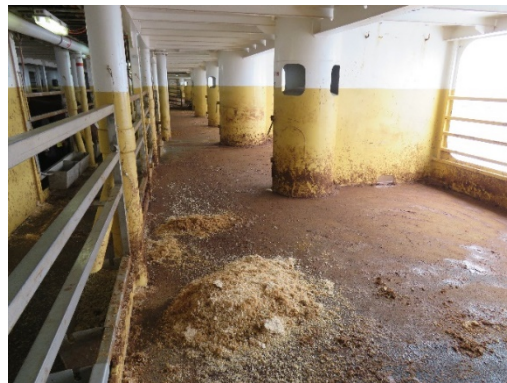
Day 3 Pad drying out after flooding

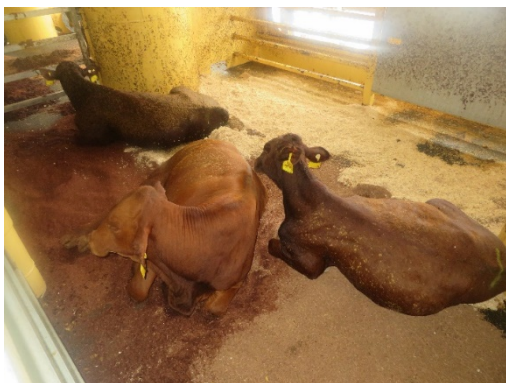
Day 7 Cattle in hospital pen—no issues identified

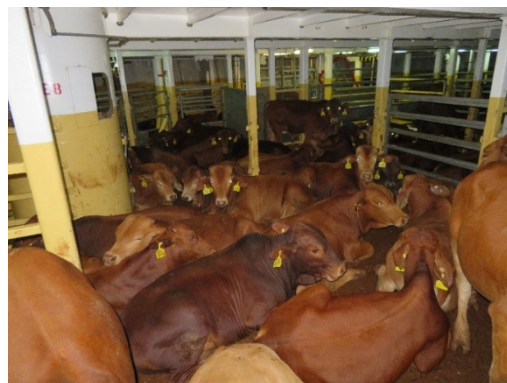
Day 2 Cattle in pen—no issues identified
