Independent Observer summary report on MV *Girolando Express*

Cattle exported to China in Dec 2019

Report 205, February 2020

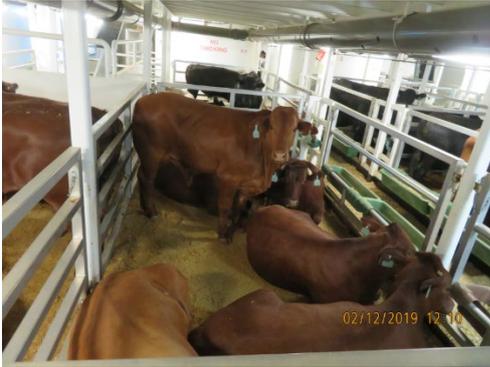
Day 2 Cattle in pen—no issues identified.

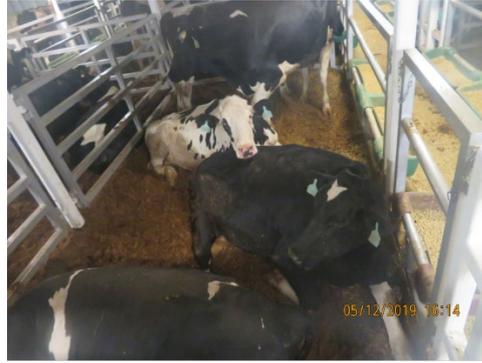
Day 5 Cattle in pen—no issues identified.

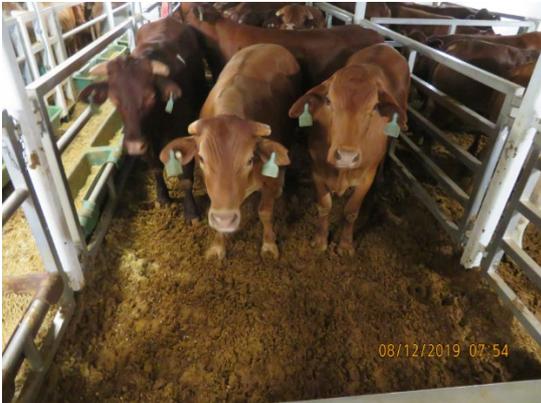
Day 8 Cattle in pen—no issues identified.

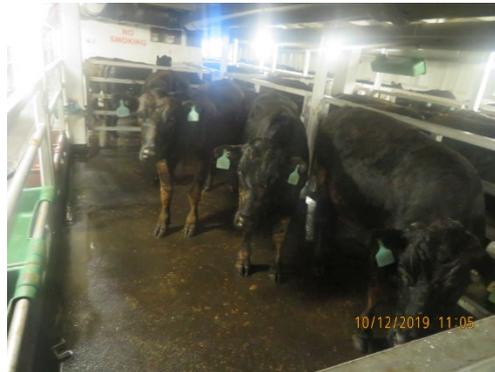
Deck washing was performed on days 10 and 11 of the voyage, with the observer reporting a consequential 2°C drop in deck temperatures. Over the days following deck wash-down, some pads became sloppier. Sawdust was applied to rectify this and no negative health or welfare effects were observed upon the cattle within affected pens.

Day 10 Cattle in pen following deck wash-down—no issues identified.

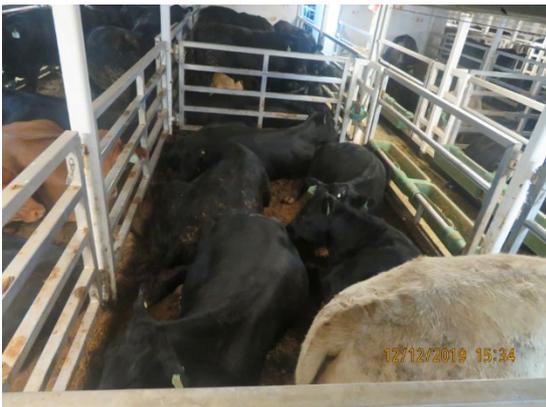
Day 12 Cattle in pen—no issues identified.

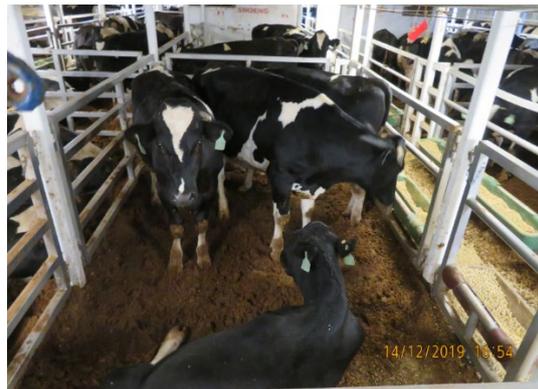
Day 14 Cattle in pen—no issues identified.
