Independent Observer summary report on MV *Maysora*

Cattle and sheep exported to Israel and Jordan in September 2018

Report 21, October 2019

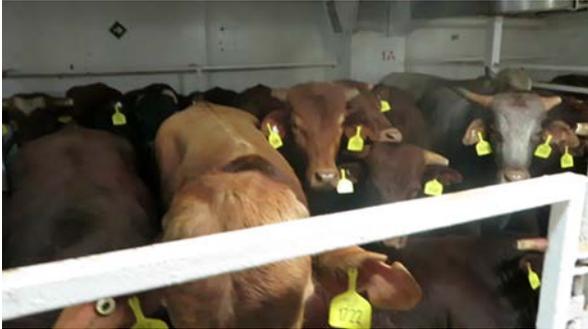
Day 3 Cattle in pen—no issues identified

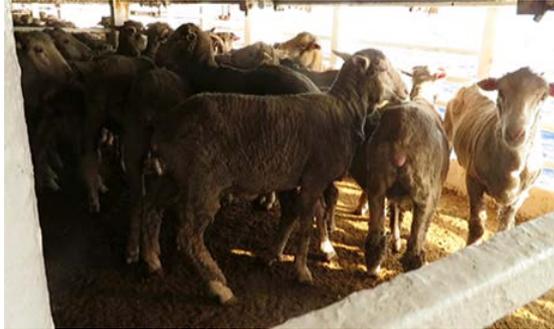
Day 6 Sheep in pen—no issues identified

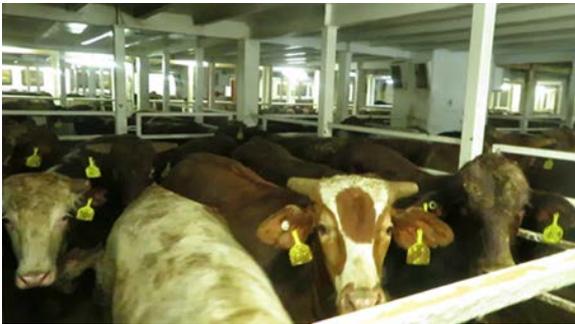
Day 10 Cattle in pen—no issues identified

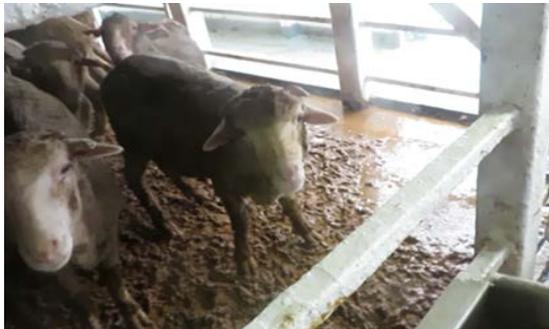
Day 11 Sheep in pen—no issues identified

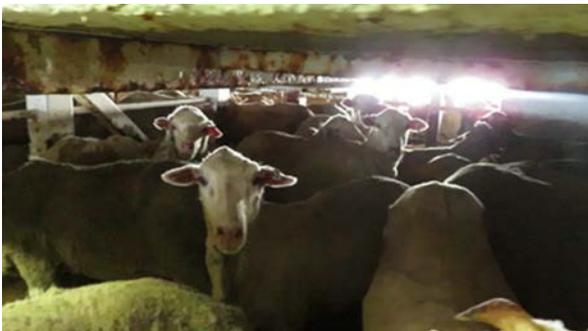
Day 16 Sheep in pen—no issues identified

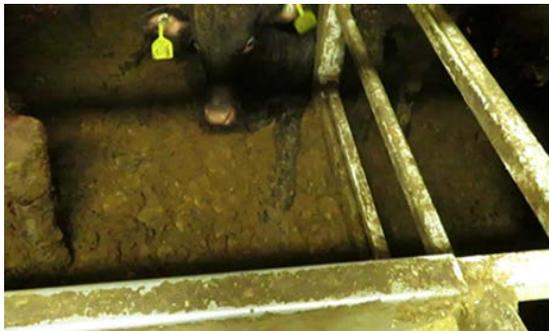
Day 19 Cattle in pen—no issues identified
