# Independent Observer summary report on MV Bahijah

## Sheep and cattle exported to Israel in December 2018

Report 50, February 2020

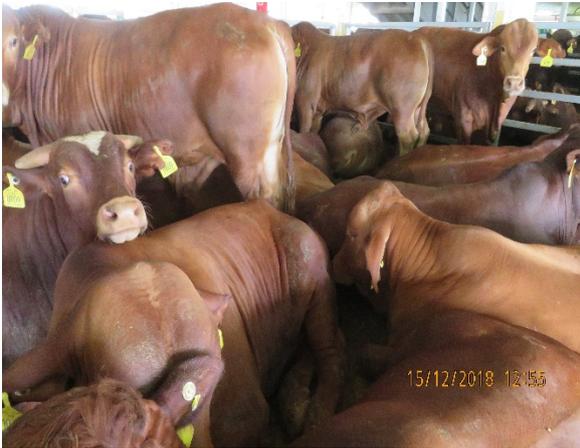
At the time of loading, in the observer's opinion, many of the bulls in some pens on Deck 5 appeared to be significantly heavier than the average body weight listed in the load plan (identified as medium bulls on the load plan) resulting in pens that appeared to be visibly overstocked. The observer raised concerns related to these observations without any visible response. Later in the voyage an amended load plan was supplied that indicated that heavy bulls were in the relevant pens. The amended plan also included an increased average weight across all classes of sheep and cattle.

The observer believed that a number of pens were overstocked as some cattle loaded into the relevant pens were visually of a greater weight than the average weight used to calculate the pen numbers in the load plan.

**Day 1 Observer concern with heavy visual stocking density**

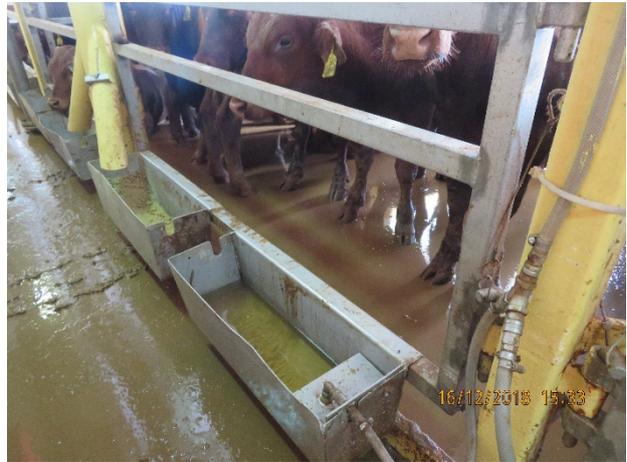
There was a rapid build-up of manure in the cattle pens and the cattle decks were washed six times during the voyage. Prior to washing, the conditions were very boggy in some pens. Sawdust was not used in the pens after the deck washes except the wash prior to unloading.

During the first 2 days of the voyage, the vessel was impacted by severe weather that flooded Decks 5 and 6 and left the stowed pallets of chaff and bedding in disarray. Activities were undertaken to identify clinically lame cattle following the rough conditions and to transfer them to hospital pens for treatment. The daily reports included that 3 cattle were euthanased as they were unable to stand with bilateral sole ulcers on day 11. Day 12 included a mortality due to septic arthritis. The daily reports did not reflect the observer's observation of a situation of deteriorating lameness between days 1 and 11 following the rough weather.

**Day 2 Cattle in wet pen**

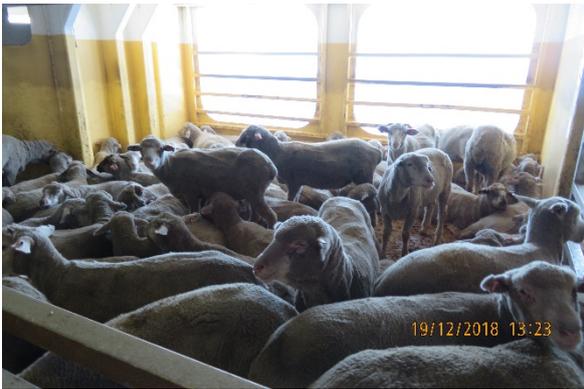
**Day 5 Sheep in pen—no issues identified**

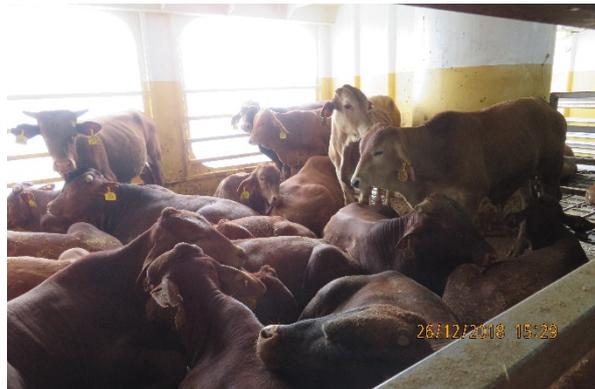
**Day 12 Cattle in pen—no issues identified**

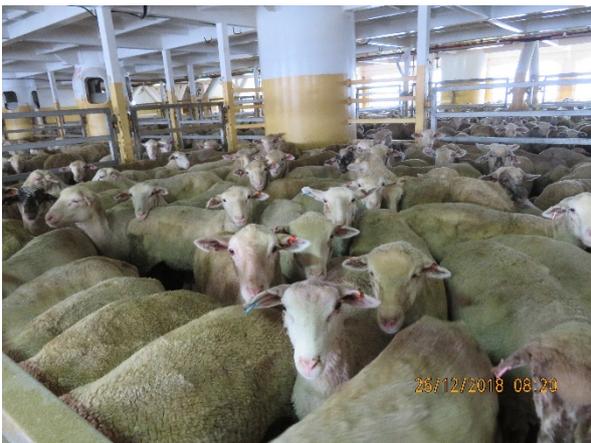
**Day 12 Sheep in pen—no issues identified**

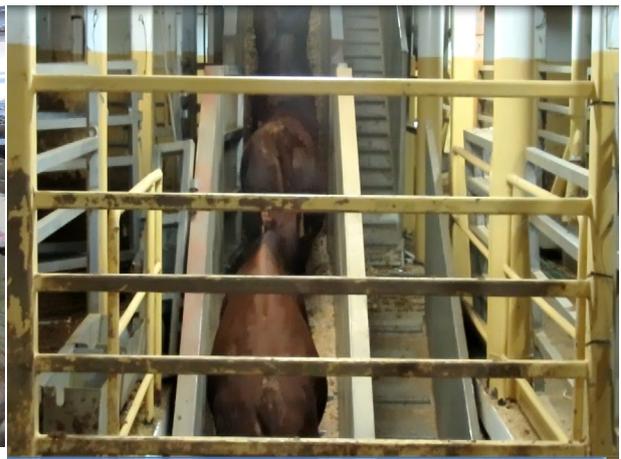
**Discharge—Cattle leaving lower decks**
