Independent Observer summary report on *MV Dareen*

Cattle exported to Vietnam in December 2018

Report 51, October 2019

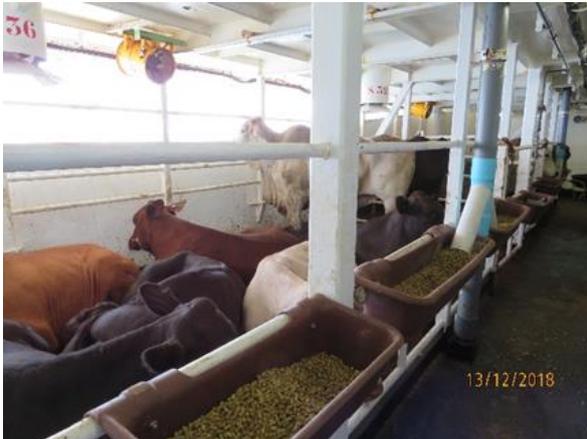
Day 2 Cattle in pen — no issues identified

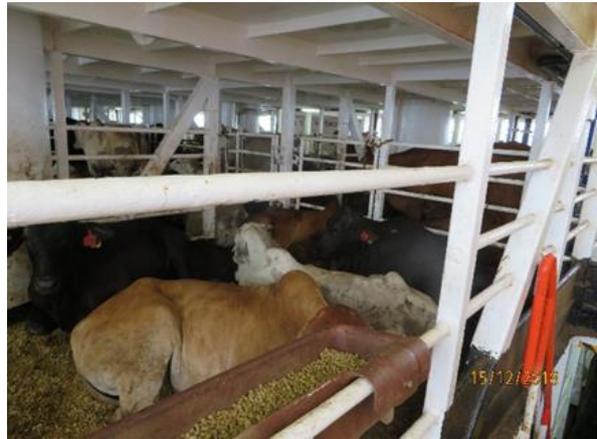
Day 4 Cattle in pen — no issues identified

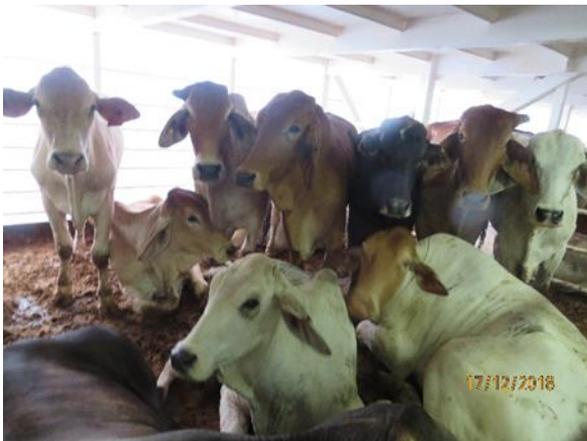
Day 6 Cattle in pen — no issues identified

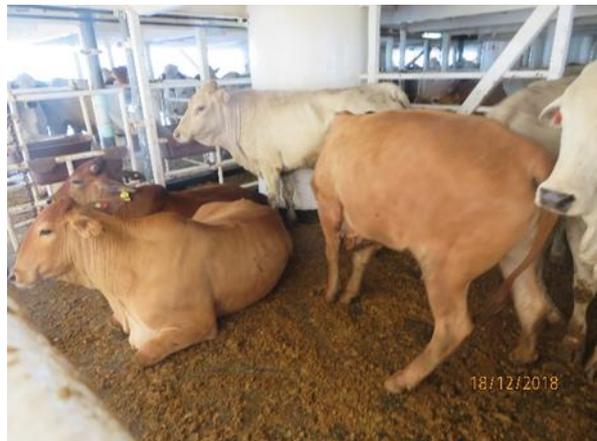
Day 7 Cattle in pen — no issues identified

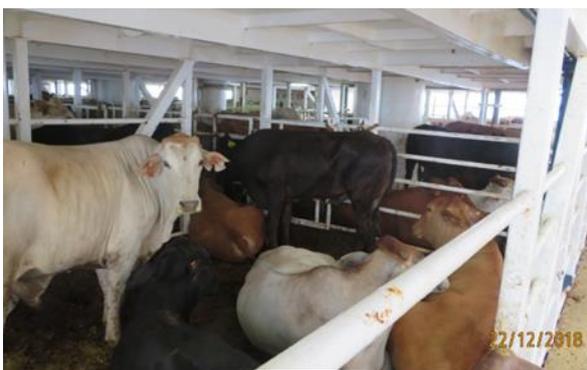
Day 11 Cattle in pen — no issues identified

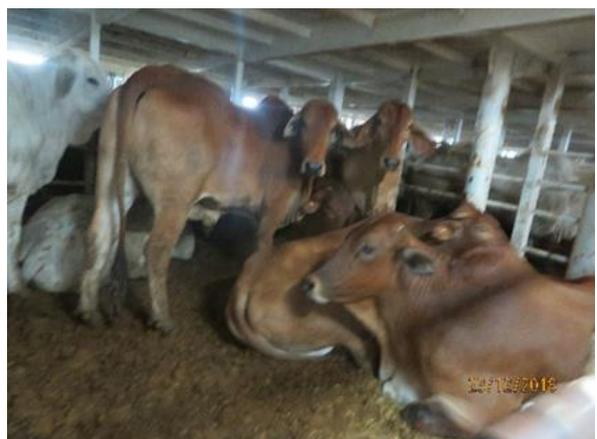
Day 12 Cattle in pen — lower stocking density
