Independent Observer summary report on *MV Rahmeh*

Cattle exported to Vietnam in January 2019

Report 63, October 2019

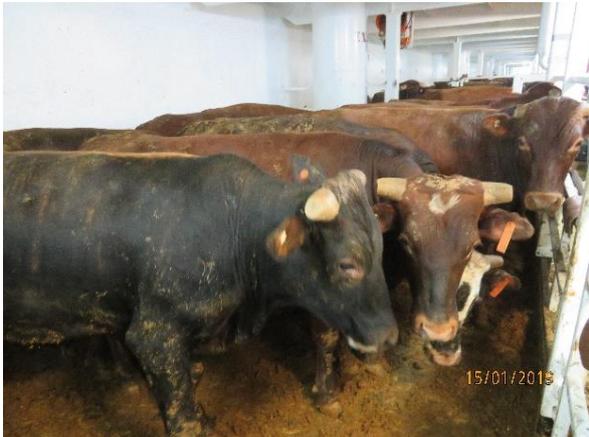
Day 3 Cattle in pen – at full stocking density

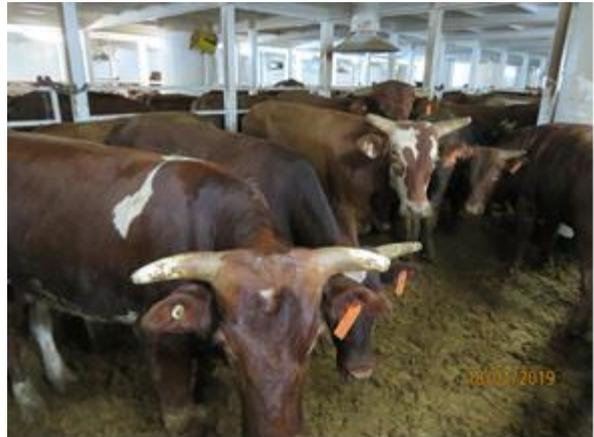
Day 6 Cattle in pen – no issues identified

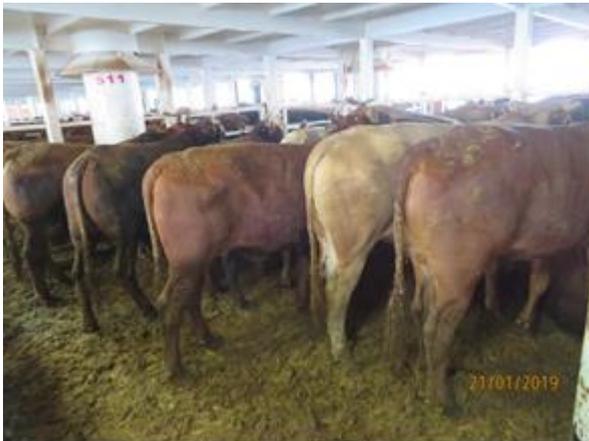
Day 9 Cattle in pen - no issues identified

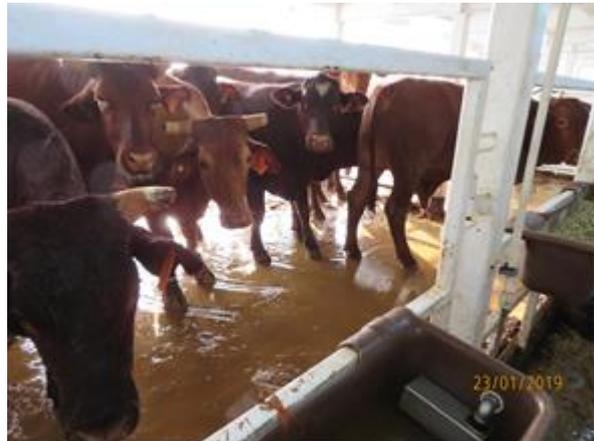
Pens in Decks 4, 5, 6 and 7 became wet and sloppy from sea water inundation resulting from the large swell during the voyage. Decks 4 and 5 were first washed on day 2.

Cattle in pen - wet pens inundation by swell

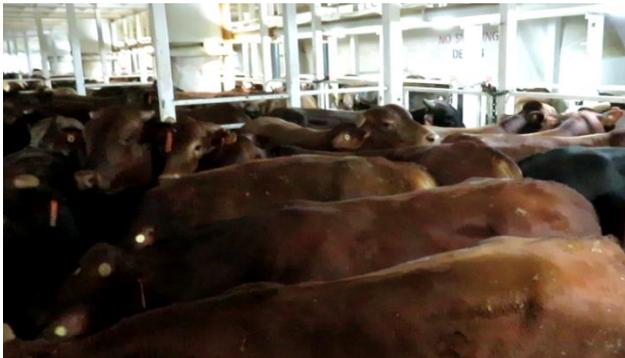
Day 15 Cattle in pen – full stocking density

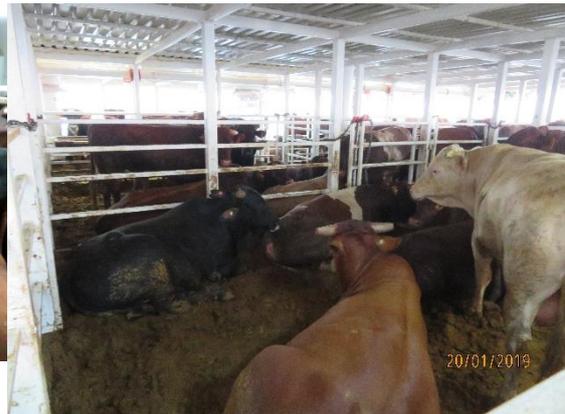
Day 16 Cattle in pen - low stocking density
