# Independent Observer summary report on *MV Dareen*

## Cattle exported to Vietnam in February 2019

Report 89, September 2019

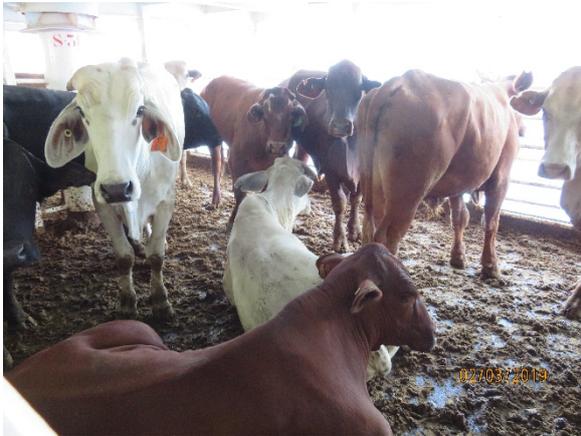
**Day 3 Cattle in pen - no issues identified**

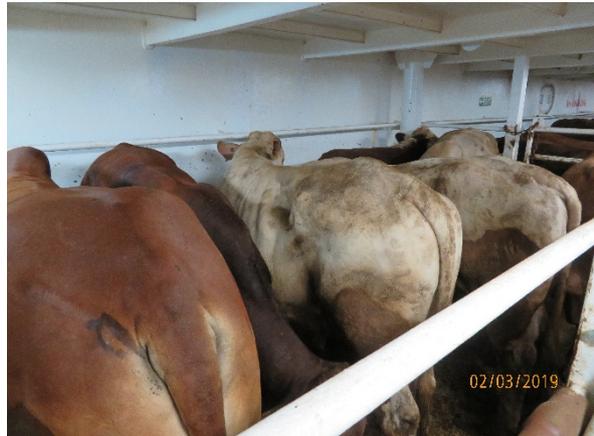
The observer noted that approximately 70% of pens had more space per head that required in the *Australian Standards for the Export of Livestock (Version 2.3) 2011* ([ASEL](#)) requirements. Approximately 30% of the pens had stocking density above the ASEL minimum requirements. Some pens were adjusted to provide the minimum space in accordance with ASEL requirements however, at the end of the voyage some of the pens with higher stocking density had not been adjusted.

In the pens with the lower stocking densities, nearly all cattle were observed to be able to lay down at any one time. In the pens with stocking densities which met the ASEL standards, approximately 50% of cattle were observed laying down at any one time. In the pens with higher stocking densities, only 20% or less were observed laying down at any one time.

**Day 4 Cattle in pen - higher stocking density**

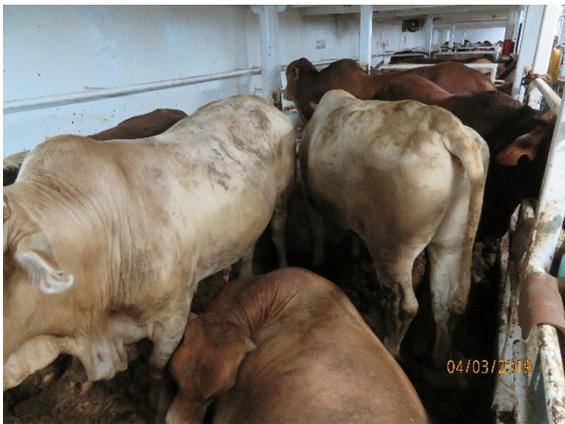
**Day 5 Cattle in pen - no issues identified**

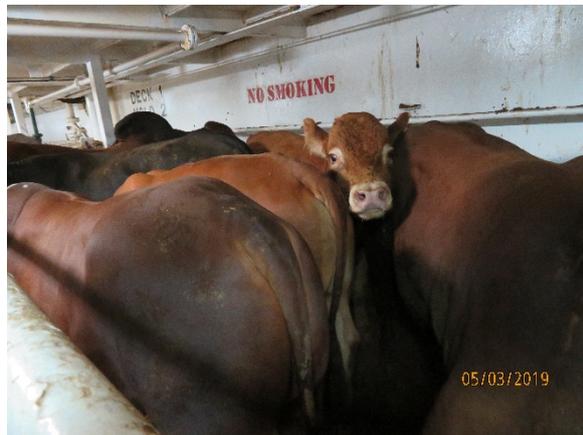
**Day 6 Cattle in pen - higher stocking density**

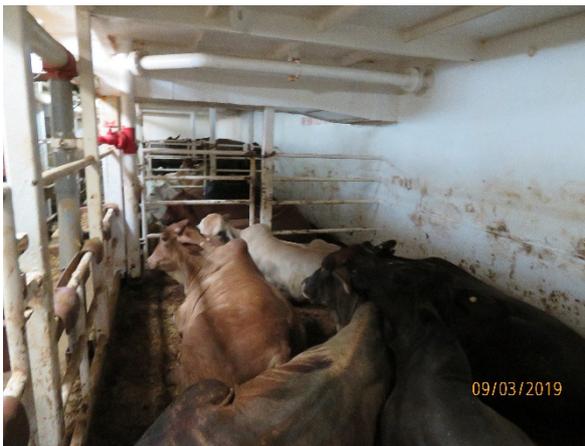
**Day 10 Cattle in pen - no issues identified**

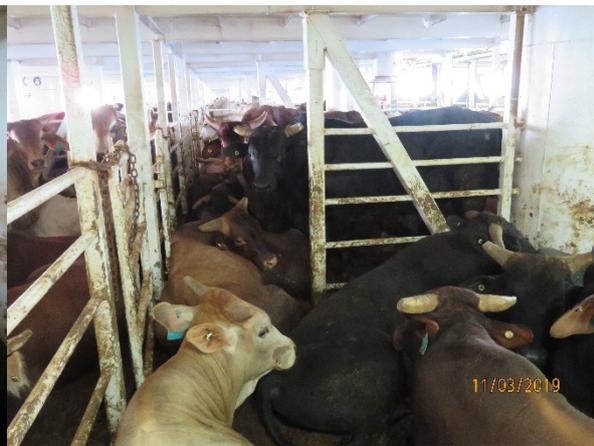
**Day 12 Cattle in pen - no issues identified**
