Independent Observer summary report on MV *Shorthorn Express*

Cattle exported to China in December 2018

Report 55, February 2020

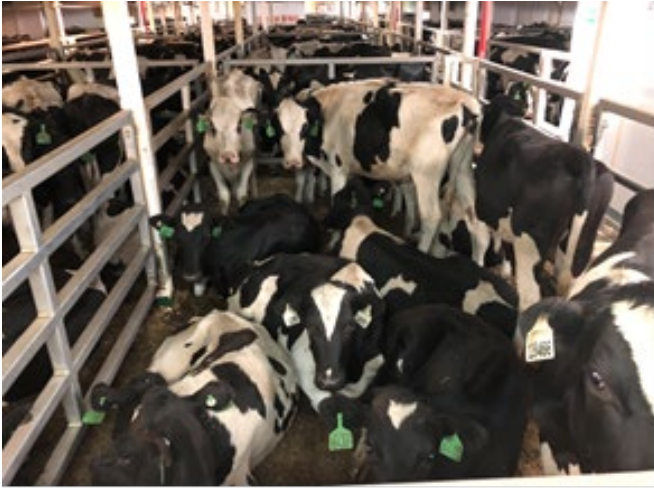
Day 1 Cattle in pen – no issues identified

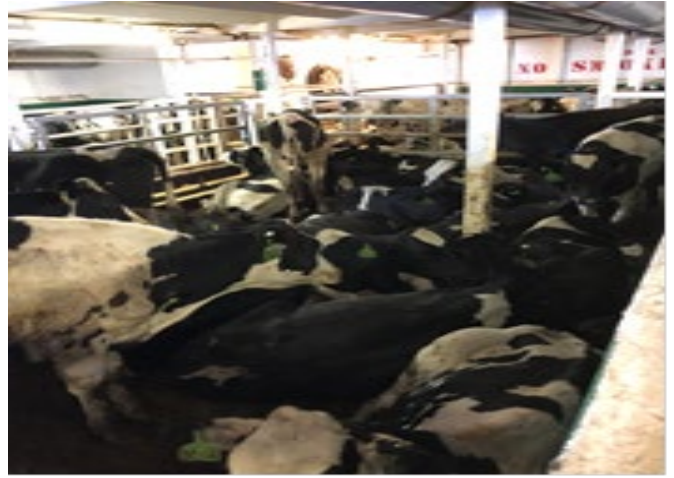
Day 4 Cattle in pen – no issues identified

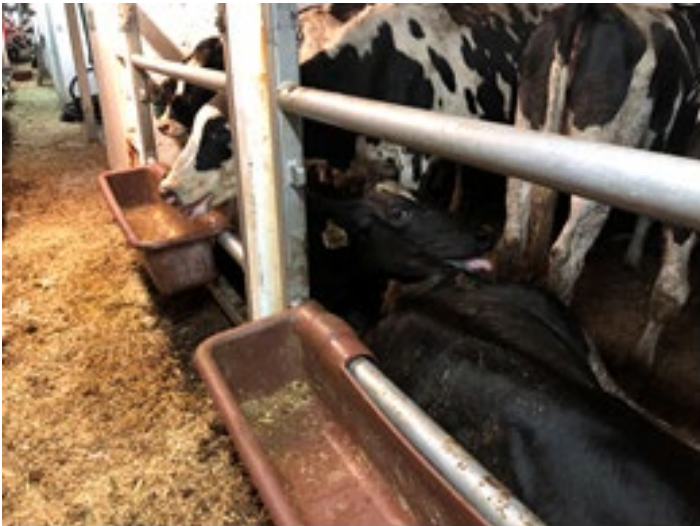
Days 7-15 recorded wet bulb temperatures ranging from 29-34°C as the vessel crossed the equatorial region. Varying degrees of heat stress became apparent to the observer over these days. Most animals exhibited behaviours consistent with a heat stress score of 0-2. These adverse environmental conditions, particularly noted by the observer in pens close to the engine room and ventilation shafts, coupled with the lack of continuous water supply, contributed to the increased susceptibility of up to 5% animals who were observed with a heat stress score of 4 over days 7-13. A reported <10% of cattle were more affected on days 7-9, and were ascribed heat stress scores from 3.5 to 4 by the observer. By day 15, the average wet bulb temperature reduced to 25°C, with no cattle observed affected by heat.

Day 6 Cattle showing heat stress

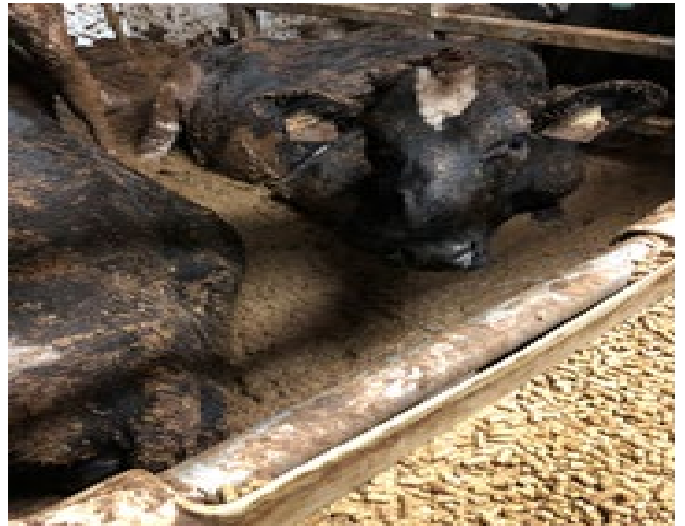
The observer noted that although the number of crew on-board the vessel seemed to be sufficient, generally their application to pen and deck cleaning tasks and maintenance was considered unsatisfactory. Poor maintenance, for example, not attending to leaks in the water supply system or broken nose bowls, contributed to a 20cm deep build-up of a boggy mixture of fodder, chaff and manure in most alleyways and pens.

The observer commented that unsatisfactory pen and deck conditions were experienced during the voyage. These conditions were mainly due to inadequate corrective maintenance by crew, leaking water pipes and fire hydrants, malfunctioning nose bowls, build-up of the thickness of the pad, spilled feed in the aisles, high temperatures and humidity and blocked drains.

Day 7 Cattle in poor pen conditions

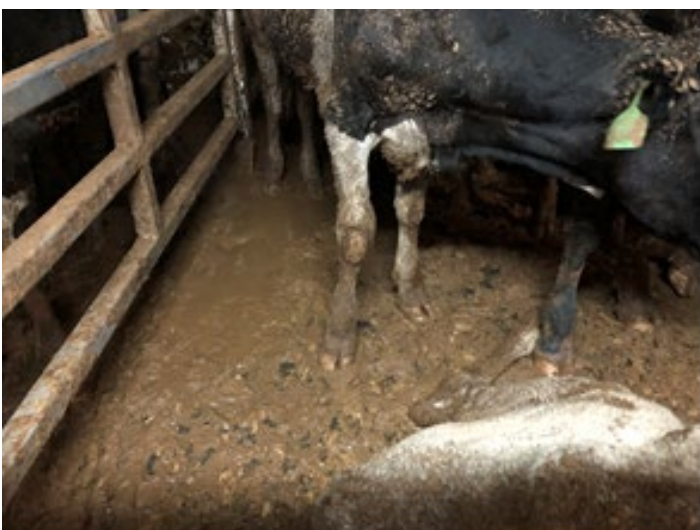
Washing of decks commenced on Day 7, with Deck 1 washed five times throughout the voyage. The remaining four decks were washed four times each on days 8/9, 12, 15 and 18. Wash down was observed to improve pen, environmental and animal welfare conditions.

Day 13 Cattle in pen after deckwash

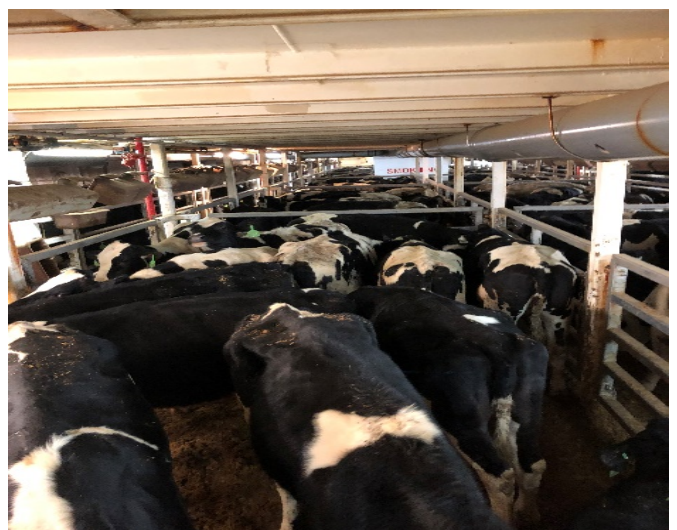
Day 18 Cattle in pen – no issues identified
