# Fire on board the livestock carrier *Ocean Drover*

Fremantle, Western Australia | 9 October 2014

**ATSB Transport Safety Report**  
Marine Occurrence Investigation  
315-MO-2014-012  
Final – 11 March 2016

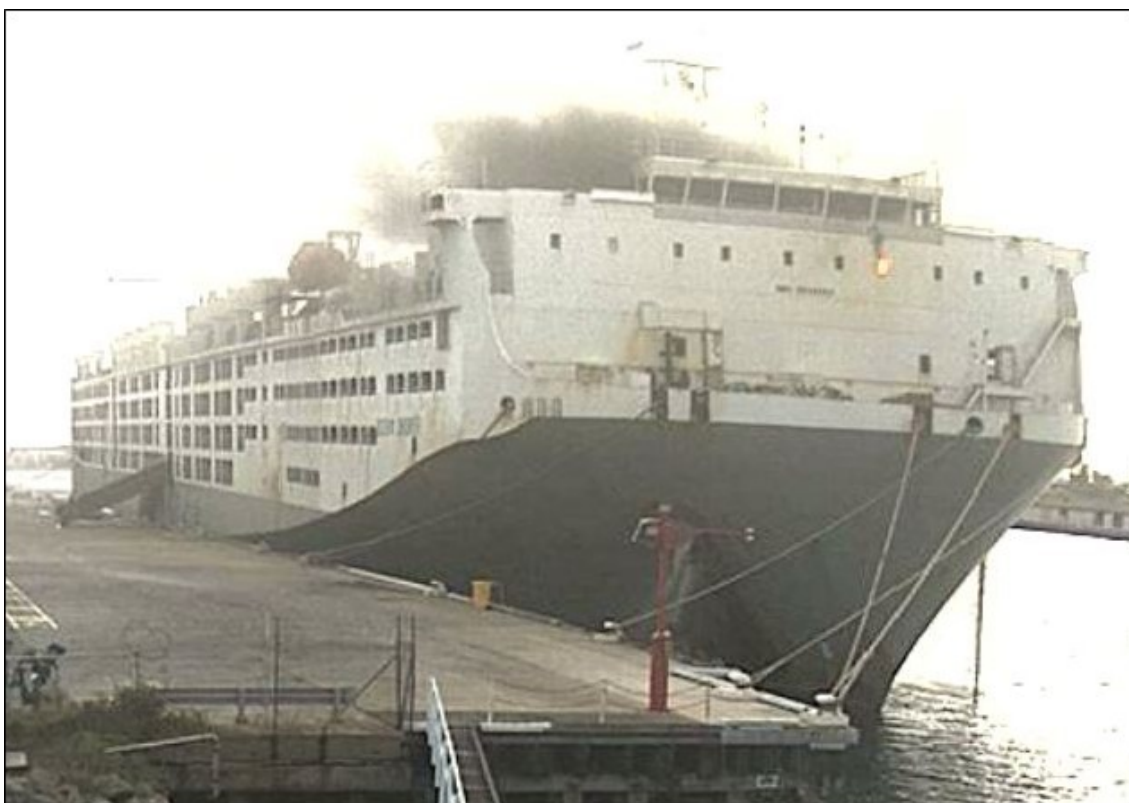
**Figure 4: Wharf CCTV footage at about 0800 clearly shows flames in cabin 4**

Shortly after 0745, when oiler 2 left his cabin, he immediately smelled smoke and heard a crackling sound. He traced the sound to the nearby cabin 4. He opened the door and was confronted by flames, intense heat and thick, black smoke. He dropped to his hands and knees and hurried away toward the officer's mess room to raise the alarm. The door of cabin 4 remained open.

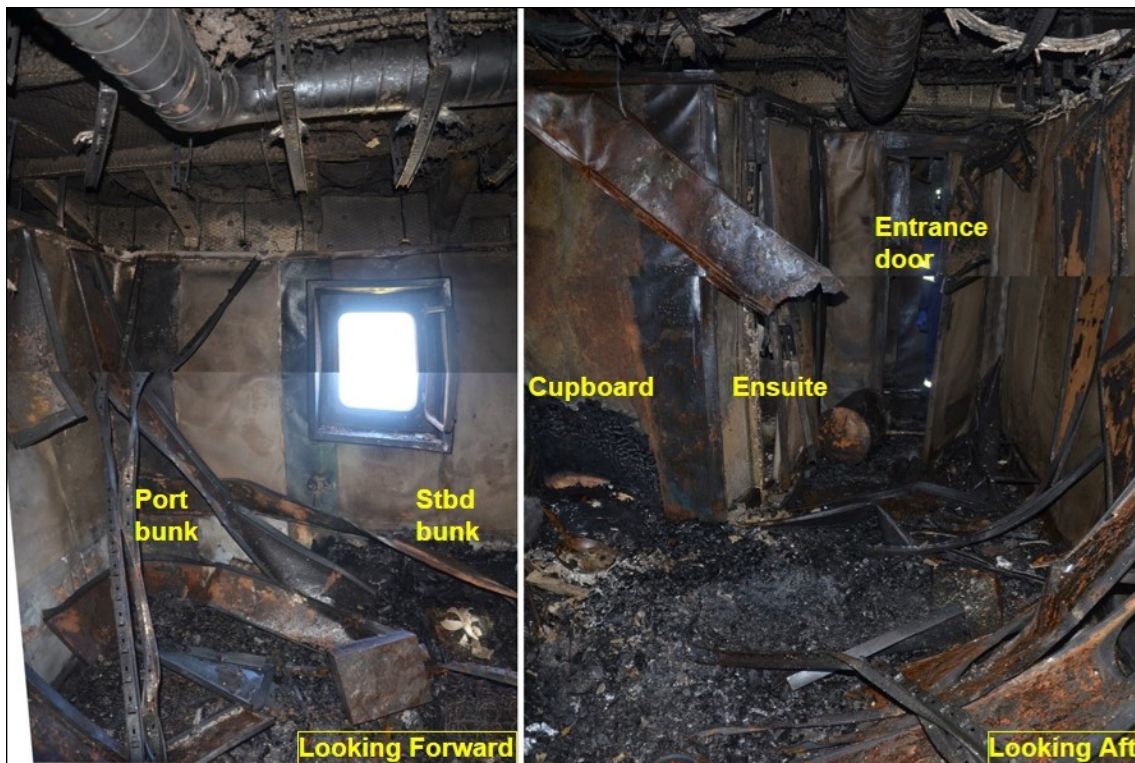
**Figure 5: Interior of cabin 4 when first accessed after the fire**

The fire burned for several hours at temperatures that exceeded 1,100 °C. As a result of the intensity of the fire and the severity of the damage, an exact point of origin or source of the fire could not be identified. However, the evidence, including witness statements, indicates that the fire originated in cabin 4 (Figure 5). The arson squad did not find any evidence of suspicious activity.

No evidence was found to show that the fire started from an electrical fault or appliance. None of the crewmembers interviewed indicated that they had experienced any problems with the ship's electrical systems.

Self-extinguishing safety ashtrays were provided for use. However, evidence was found that unapproved items, such as plastic water bottles used as makeshift ashtrays, were also used in cabins. This indicates that the smoking policy and associated risk controls on board *Ocean Drover* were not effectively managed.

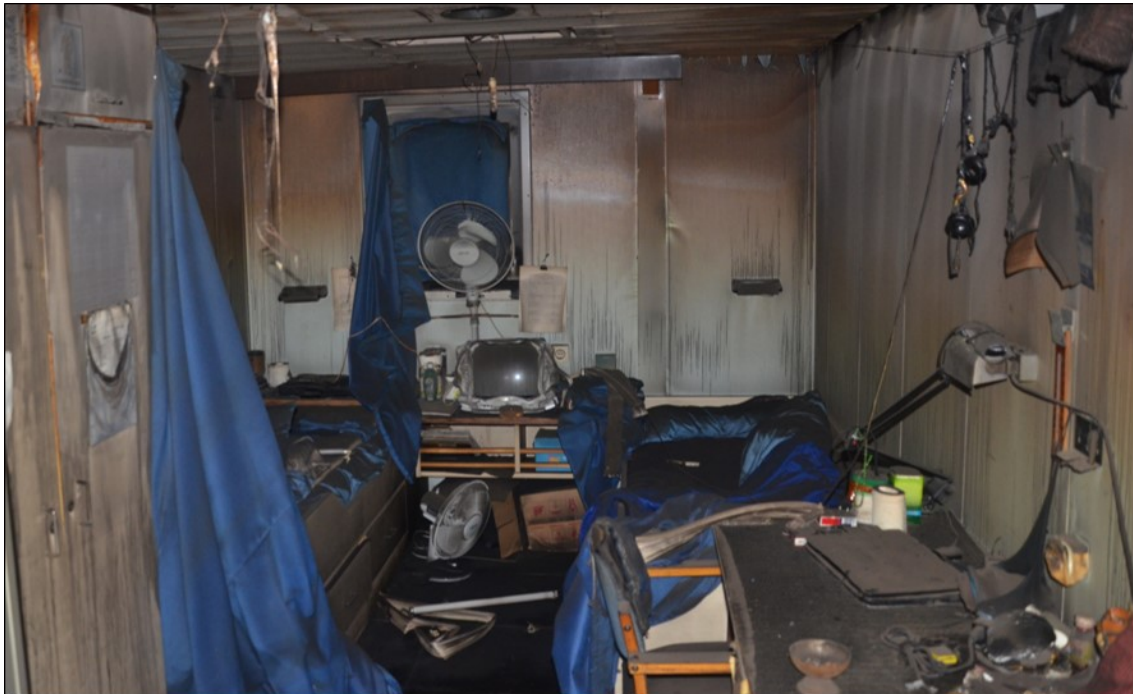
**Figure 6: A two-berth cabin after the fire (note fuel load and possible ignition sources)**

The intensity of a fire will depend, in part, upon the amount of fuel available to burn. The fuel load will also affect the speed at which a fire will grow and spread. To limit the potential for fire growth, the types and quantities of the materials used in a cargo ship's accommodation are regulated. There is no restriction, however, on the quality (or quantity) of the furniture, bedding and furnishings used to fit out cabins, offices or public spaces. As the number of personnel on board increases, the amount of such material will also increase. In addition, each person will bring personal and work items, such as clothing, on board with them. Therefore, the more personnel on board, the more potential fuel that is available to feed a fire.

Furthermore, *Ocean Drover* had multi-berth cabins. Such cabins increased the density of the combustible materials within the accommodation space. Therefore, once the fire began, there was a significant amount of closely stowed, combustible material available to burn.

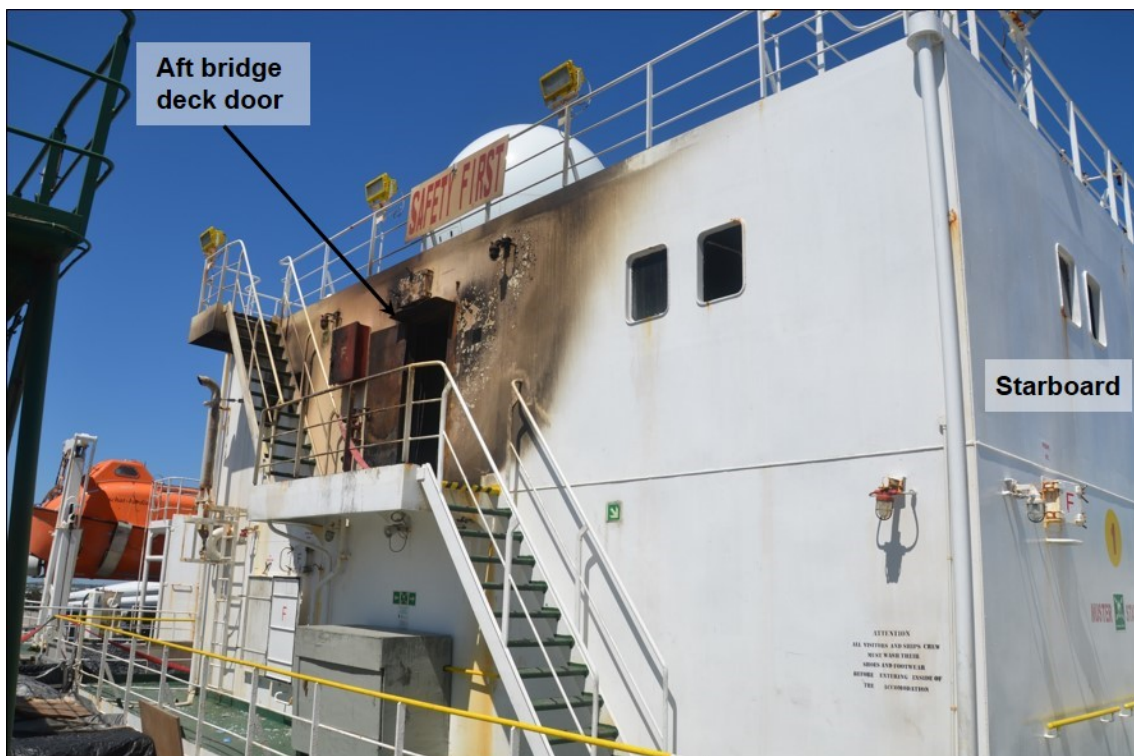
**Figure 7: Bridge deck aft (note the damage near the door, which was initially open)**

The ATSB investigation found that the cabin door was left open after the fire was discovered allowing smoke and flame to spread beyond the cabin. Further, the bridge deck stairwell fire door was hooked open, which allowed the fire to rapidly spread and engulf both the upper and bridge decks.

A fundamental firefighting technique is to ensure a fire is confined within its compartment of origin by closing all compartment openings such as doors and windows. On *Ocean Drover*, the fire would not have spread as easily as it did, and the damage would not have been as severe as it was, if the cabin door and the bridge deck fire doors had been closed.

During the post-fire repairs to the ship, the bridge deck stairwell fire door was replaced. In compliance with mandatory international regulations, this self-closing door is not fitted with a hold back arrangement. Notices posted on both sides of the door require it to be kept closed. The door is also fitted with a viewing window for additional safety.

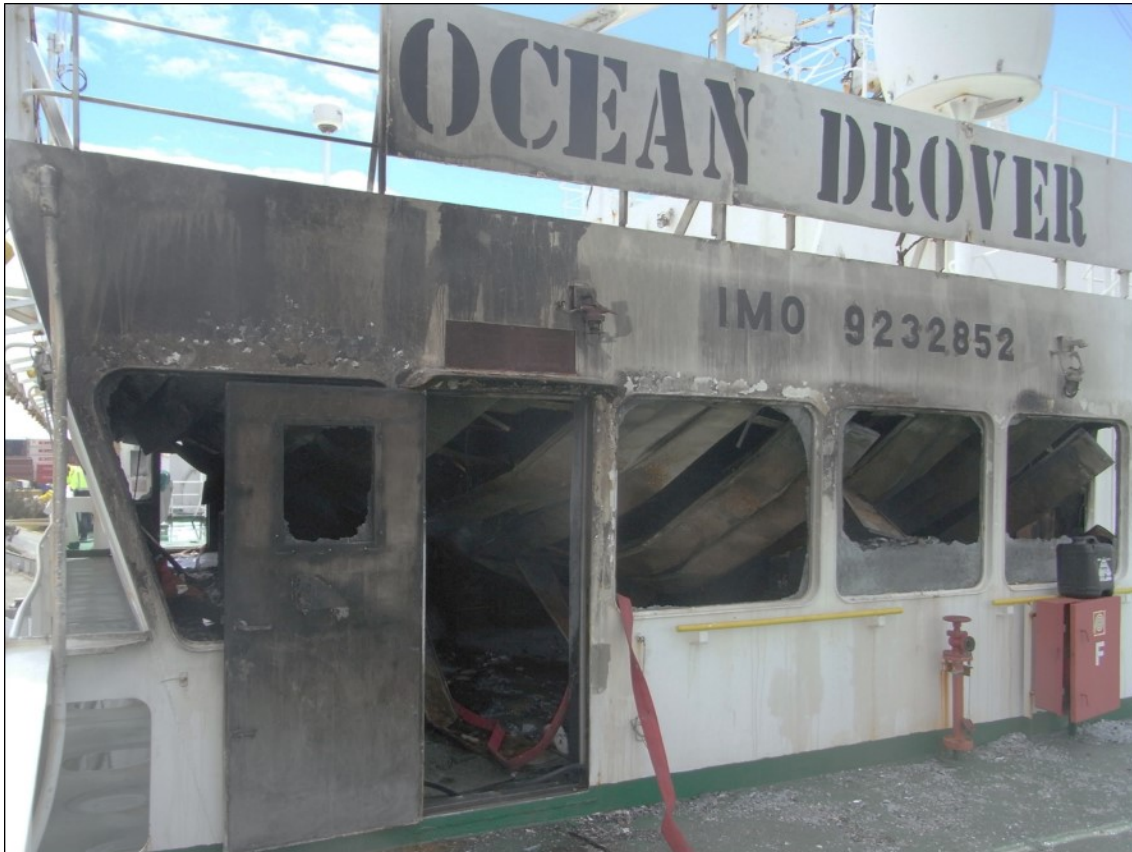
**Figure 8: Burnt out wheelhouse viewed from the port bridge wing (chartroom is aft)**

The wheelhouse of a ship is a vital communication and control area. As such, all round A-60 class boundaries protect it. During the fire, several cabins beneath the wheelhouse were severely damaged. This caused some areas of the deck of the wheelhouse to be charred and warped. The fire also consumed the ship's office and the corridor immediately aft of the wheelhouse.

damaged by fire more than 3 hours after the fire was discovered. Shortly after, the wheelhouse caught fire and was severely damaged (Figure 8).

No evidence was found to suggest that the fire breached the wheelhouse deck or aft bulkhead. The DFES investigation found that the most severe damage was in the area adjoining the ship's office. Firefighters also observed that the wheelhouse was at the point of imminent flashover at about 1200. It is likely, therefore, that a combination of the intensity and duration of the fire exceeded the fire rating of the wheelhouse boundaries. This led to ignition of combustible materials and the destruction of the wheelhouse.

During November 2014, *Ocean Drover* was towed to a shipyard in Singapore for extensive repairs to the navigation bridge (wheelhouse) and accommodation areas. The ship left the shipyard and returned to service on 18 March 2015.

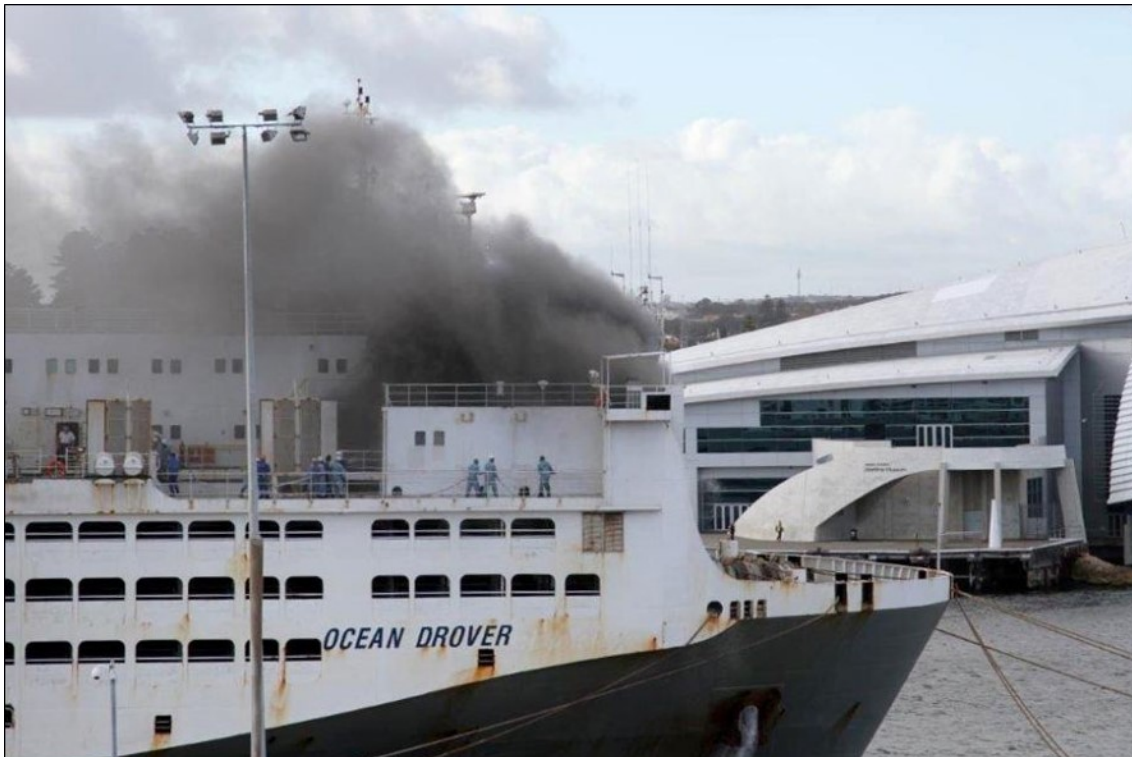
As the emergency unfolded, the ship's crew responded effectively. They followed their training and compensated for changes of leadership and personnel.

**Figure 9: Ship's crewmembers fighting the fire with water hoses**
