Independent Observer summary report on MV *Bison Express*

Cattle exported to Philippines in June 2019

Report 142, January 2020

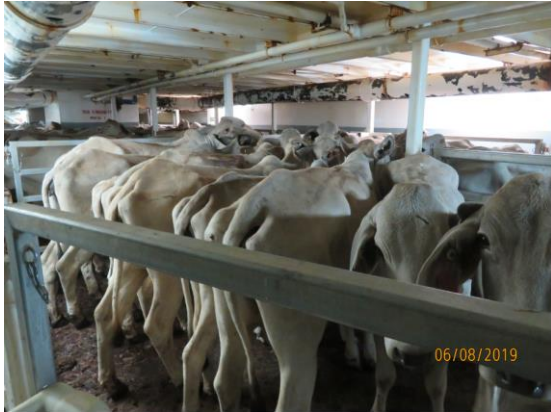
Day 2 Cattle in Pen – no issues

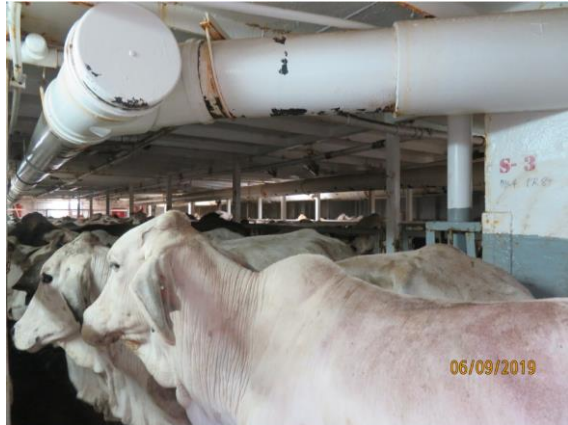
Day 3 Cattle in pen— no issues

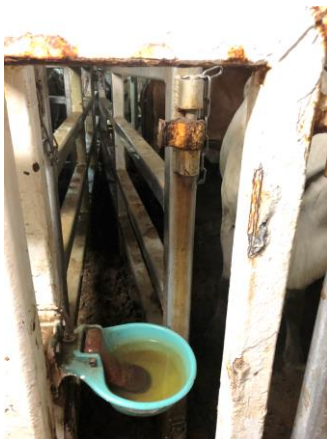
There were a number of gates which could not be done up properly and gate hinge points that had sheared off completely which had the potential to injure the cattle, although no specific health or welfare issues were noted.

Day 5 Broken gate blocking access to nose bowl

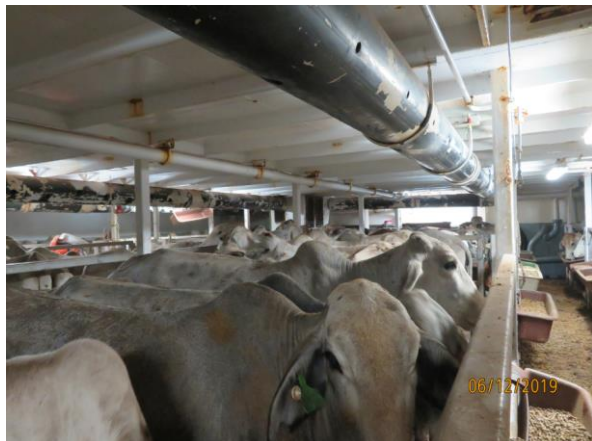
Day 6 Cattle in pen – no issues

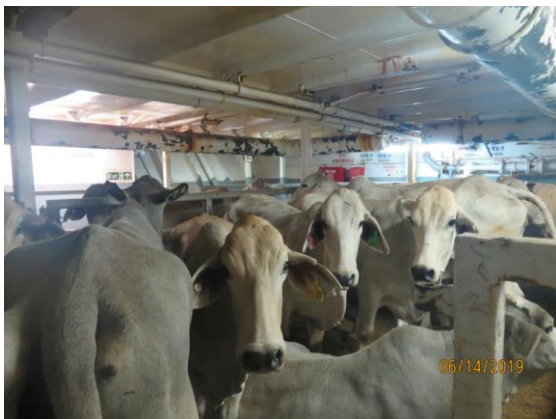
Day 8 Cattle in pen – no issues

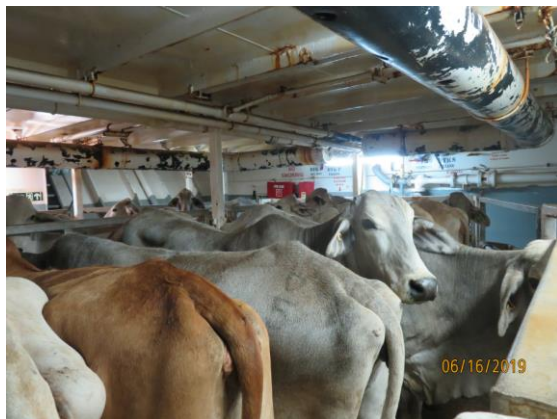
Day 10 Cattle in pen—no issues
