# Independent Observer summary report on *MV Yangtze Fortune*

## Cattle exported to China in December 2019

Report 210, April 2020

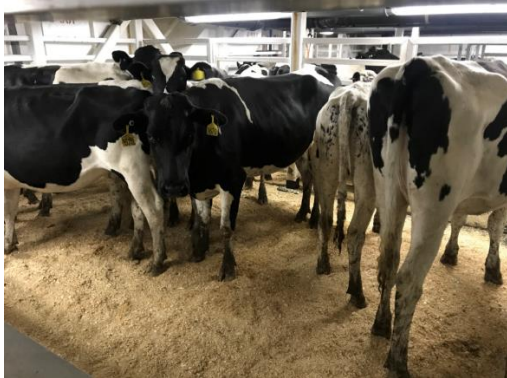
**Day 1 Cattle in pen—no issues identified**

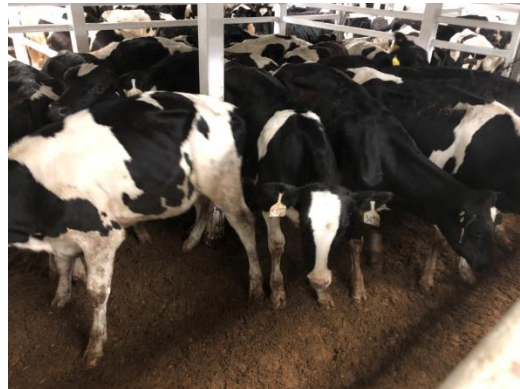
**Day 3 Cattle in pen—no issues identified**

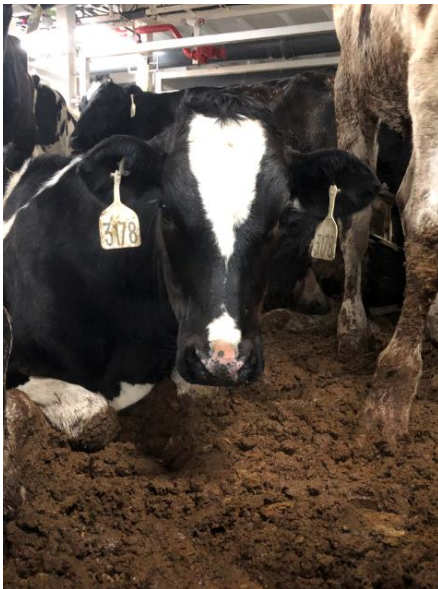
On Day 6, while ambient conditions were quite favourable, **a considerable decline in the lower deck pad conditions was observed. Relatively higher humidity was noted on these decks with animals consequently demonstrating signs consistent with a heat stress score of 1, with increased water consumption and urine production observed.** This, along with the

environmental conditions, was determined to be contributing to the decline in pad conditions. It was subsequently identified that the **ventilation system had been running at less than full capacity since departure on those decks**. The AAV had an active role in ensuring that this matter was resolved. An improvement in pad conditions and wet bulb temperatures was observed following an increase in ventilation function to full capacity.

**Day 5 Cattle pad condition on lower deck**

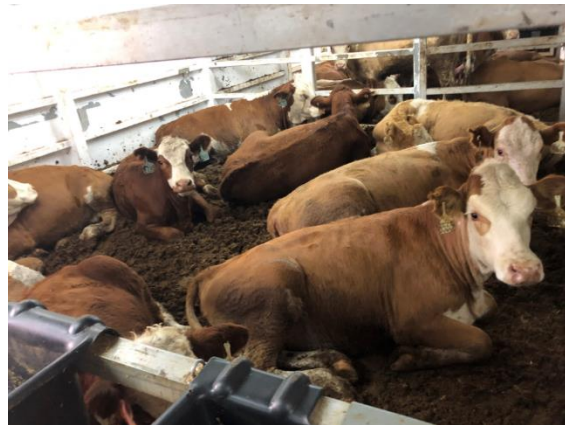
**Day 8 Cattle in pen—no issues identified**

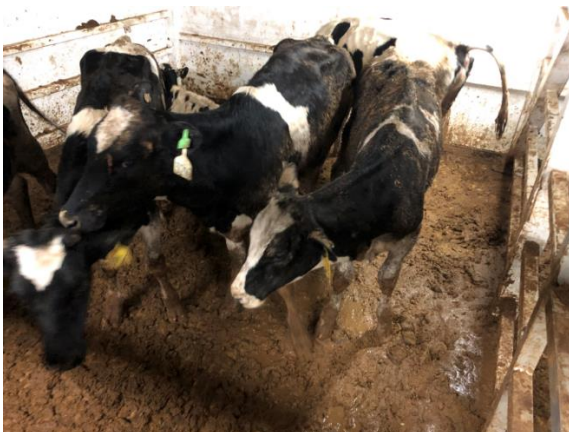
There were **numerous water flood events on all decks early in the voyage that created localised sloppy pad conditions**. These conditions were observed to be predominantly due to the cattle on decks 1-4 chewing and disconnecting the supply hoses to water troughs, however also resulted from leaking hoses, overflow of wash-down water from decks above, or the occasional ingress of sea spray through deck openings. These leaks, coupled with reported poor drainage capacity of the vessel, resulted in localised sloppy pad conditions for some animals for several hours. In contrast to this, pads on decks 5-8 were generally in a suitable dry and firm condition for the majority of the voyage, except where **localised water leaks** created wet conditions for up to 12 hours. Sawdust was immediately distributed to pens affected by these conditions. No injuries or lamenesses were reported as a result of these pad conditions.

**Cattle experienced damp pen conditions due to water leaks and poor drainage for the majority of the voyage. The IO observed an increase in visible ringworm lesions as the voyage progressed. Other than the increase in dermatitis lesions in the cattle, no obvious negative health consequences were seen in the animals affected by the poor pad conditions.**

**Day 13 Cattle in pen—moist pad conditions developing**

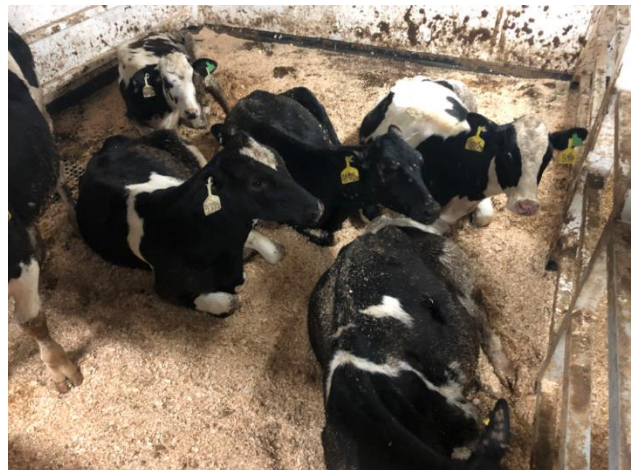
Deck wash-down occurred on Day 11 for decks 5-8 and on Day 12 for decks 1-4. A second wash-down was performed on Day 16 and 17. The observer noted that although **overflow of wash-down water encroached on the pens below**, the crew ensured that water troughs remained clean. Free water was brushed off the decks following subsequent wash-downs to reduce the accumulation of water in certain areas of the vessel.

**Day 16 Cattle in pen—following wash-down**
