# Independent Observer summary report on *MV Greyman Express*

## Cattle exported to Vietnam in February 2019

Report 78, October 2019

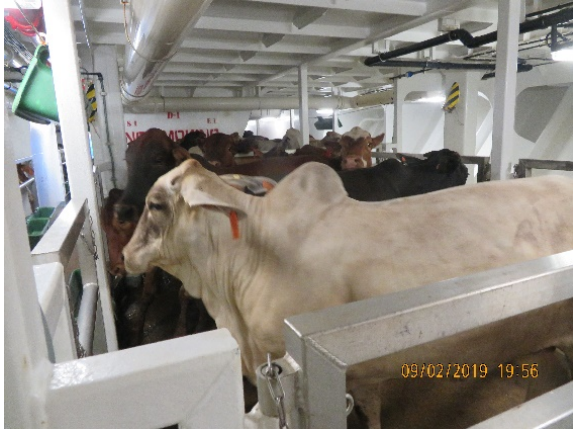
Day 1 Cattle in pen - no issues identified

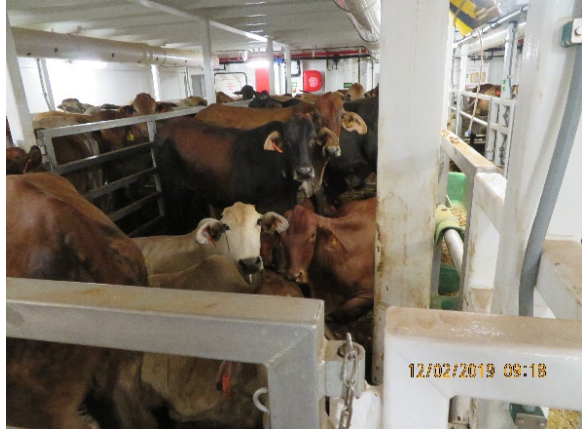
Day 4 Cattle in pen – no issues identified

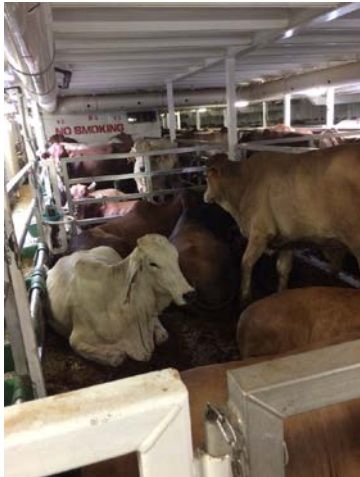
Day 4 Cattle in pen - no issues identified

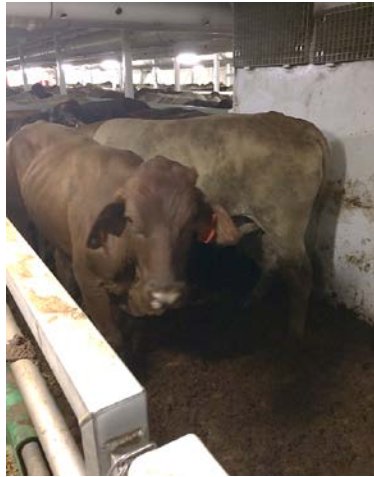
Day 5 Cattle in pen – no issues identified

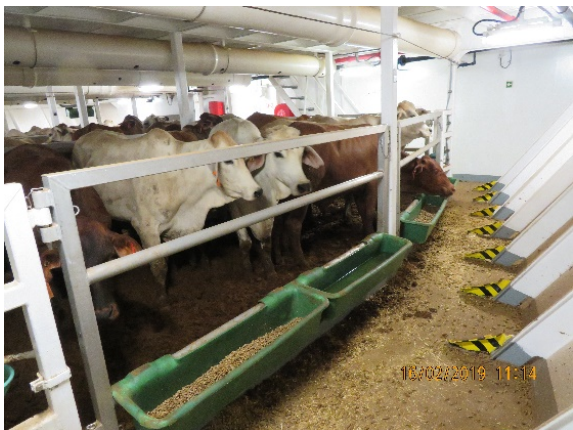
Day 7 Cattle in pen - no issues identified

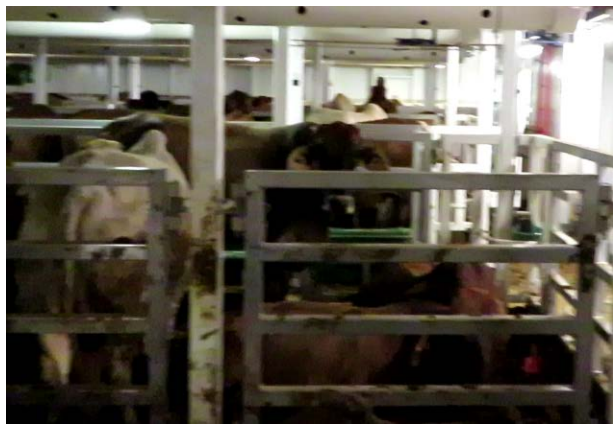
Day 8 Cattle in pen – no issues identified
