Independent Observer summary report on *MV Yangtze Fortune*

Cattle exported to China in March 2019

Report 92, October 2019

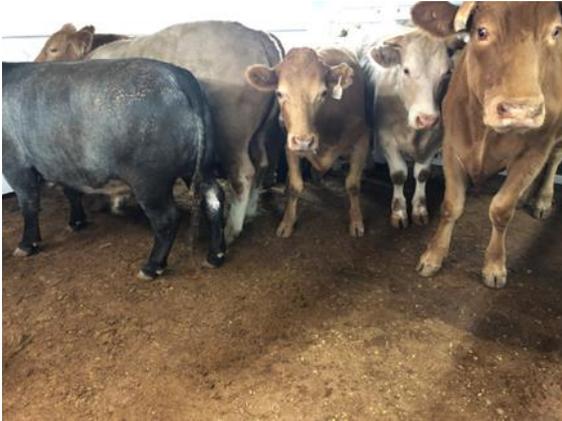
Day 3 cattle in pen—no issues identified

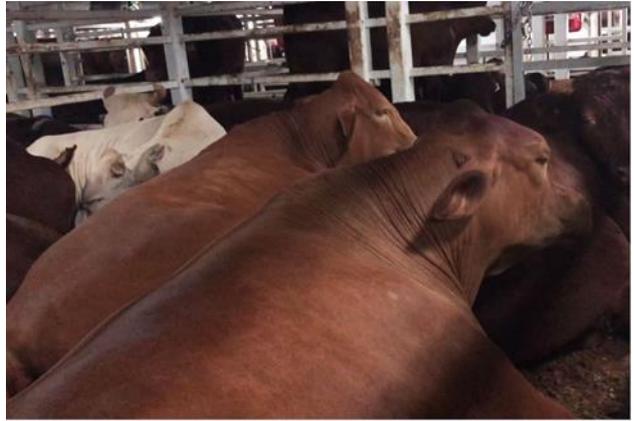
Day 5 cattle in pen—no issues identified

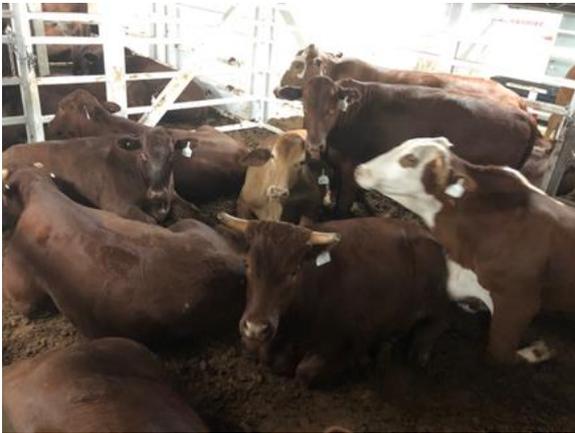
Day 7 cattle in pen—no issues identified

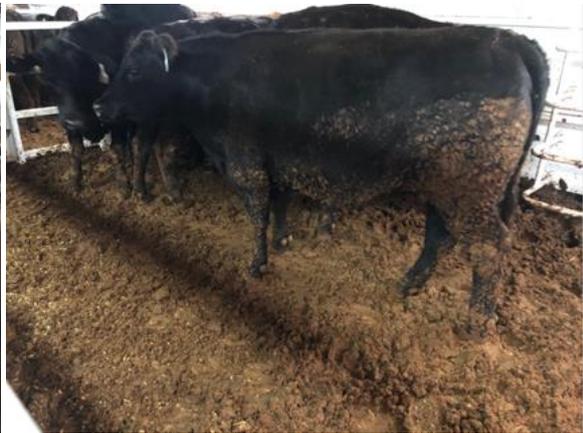
Day 9 cattle in pen—no issues identified

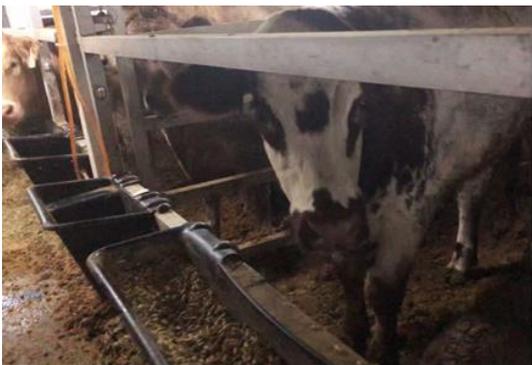
Day 15 cattle in pen—no issues identified

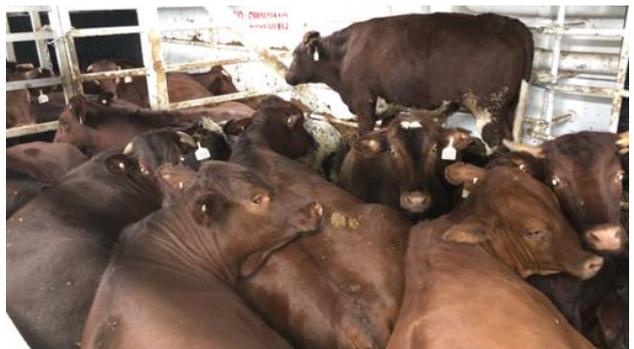
Day 16 cattle in pen—no issues identified
