Independent Observer summary report on *MV Ocean Drover*

Cattle exported to China in September 2019

Report 179, January 2020

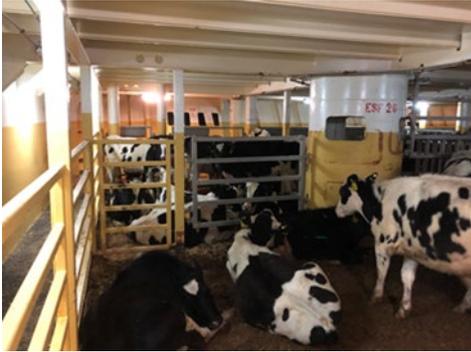
Day 3 Cattle in pen—no issues identified

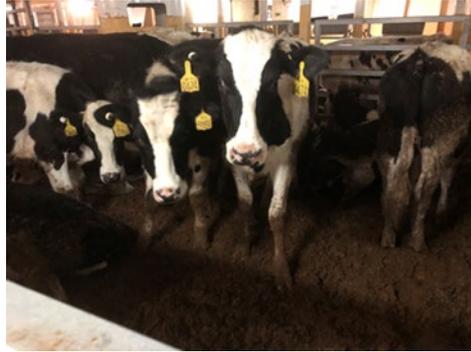
Day 7 Cattle in pen—no issues identified

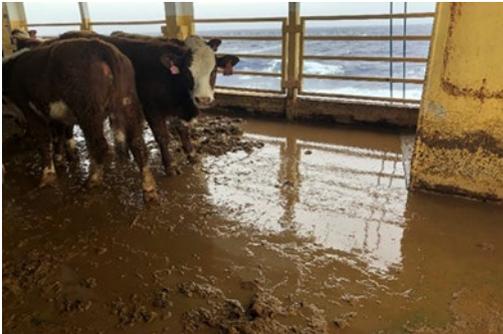
The condition of the pads in the pens on the lowest of the open decks deteriorated further with the onset of rough conditions on day 10 due to exposure to rain and direct wave action.

Day 10 Cattle in pen—rough weather

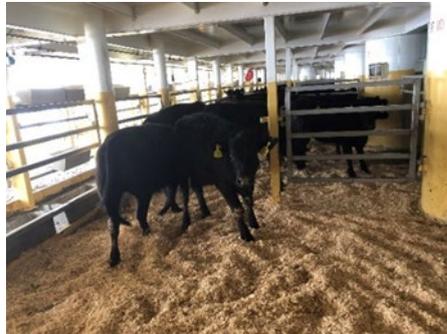
Day 11 Cattle in pen—after wash down

Wash-down of all open decks occurred on day 11 and the enclosed decks on day 12. The ongoing rough conditions necessitated a further wash-down of Deck 6 on day 14 because of ongoing wave action.

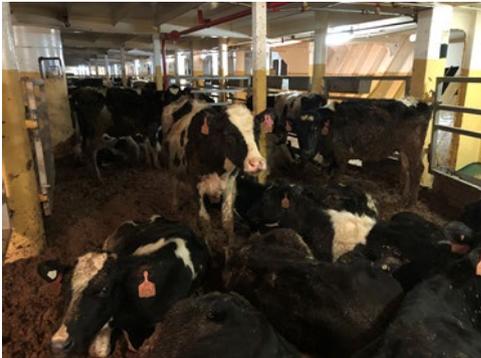
Day 15 Cattle in pen—no issues identified

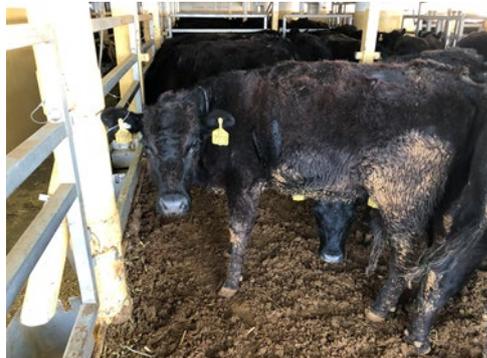
Day 16 Cattle in pen—no issues identified
