Independent Observer summary report on *MV Ocean Ute*

Cattle exported to Indonesia in January 2019

Report 65, September 2019

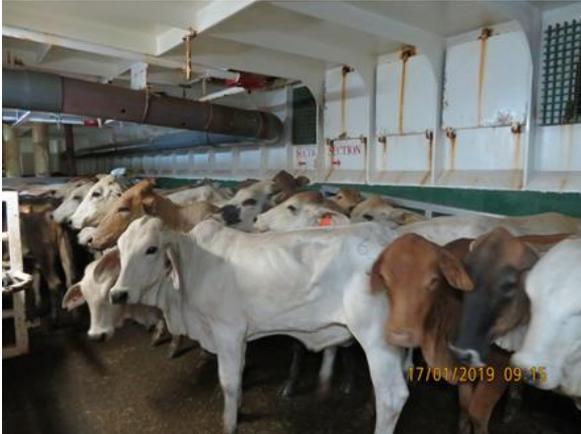
Day 1 Cattle in pen – no issues identified

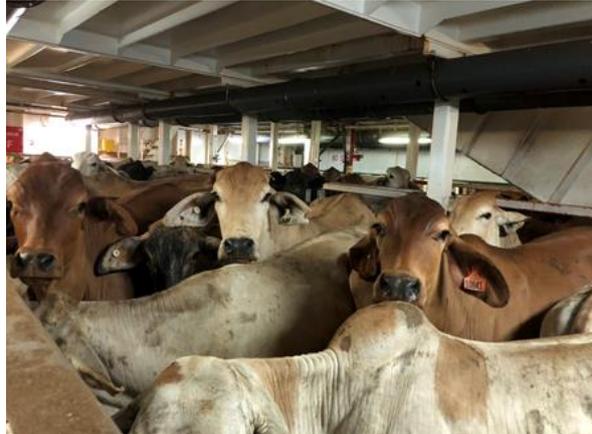
Day 3 Cattle in pen – no issues identified

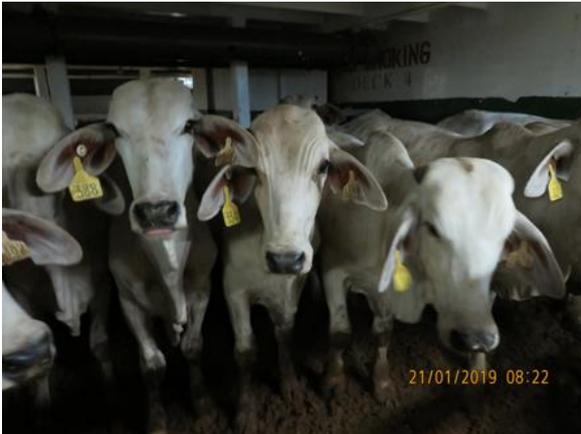
Day 5 Cattle in pen – no issues identified

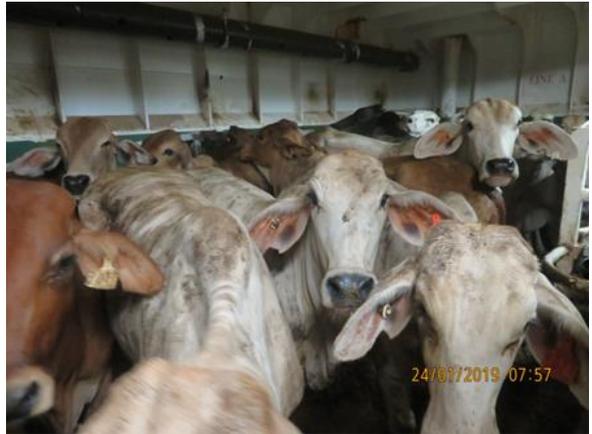
Day 8 Cattle in pen – no issues identified

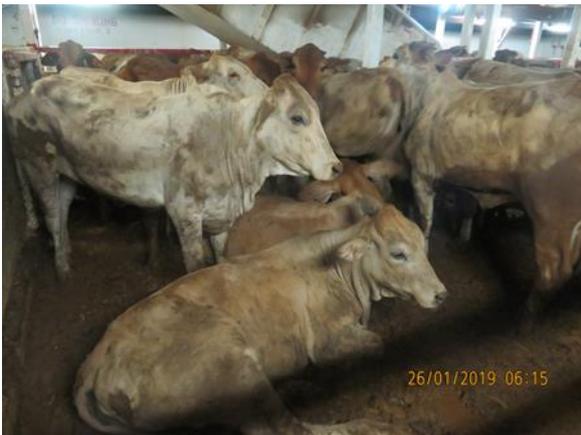
Day 10 Cattle in pen – no issues identified

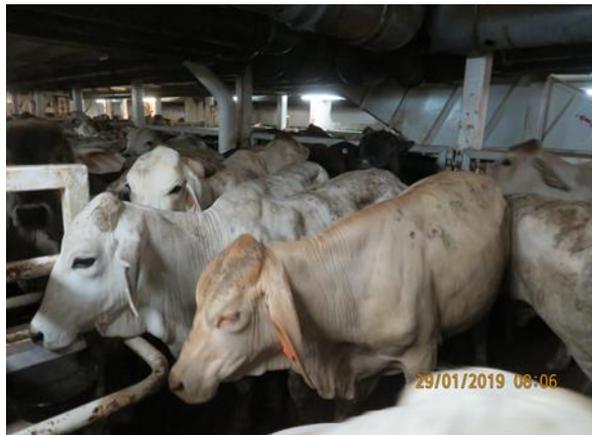
Day 13 Cattle in pen – no issues identified
