# INDEPENDENT OBSERVER REPORT ON LIVESTOCK VESSEL MAYSORA V115

FREMANTLE TO TEKIRDAG - MAY 31 TO JUNE 22, 2018

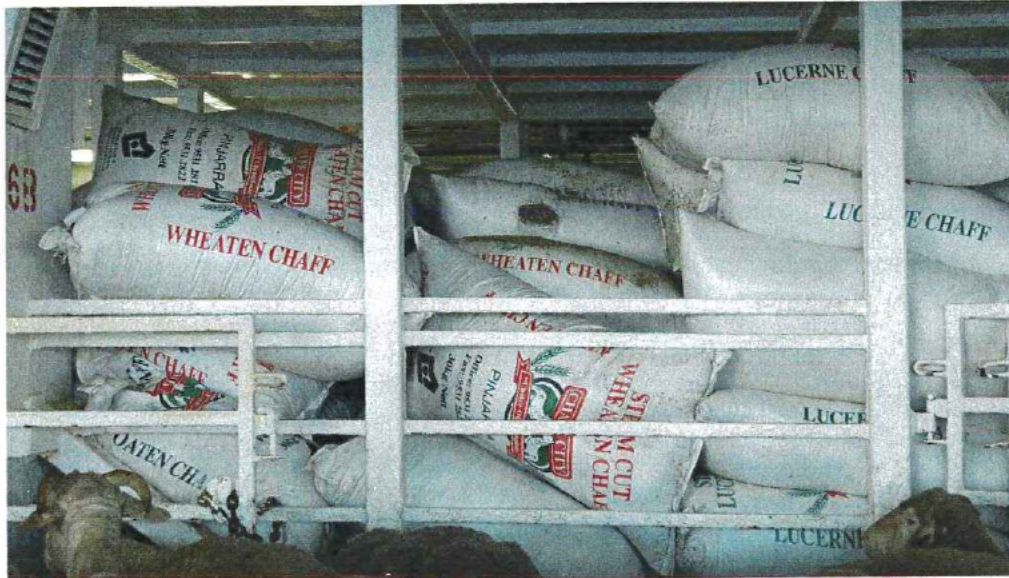
Fig 1. Chaff and saw dust stored away from environmental damage within deck

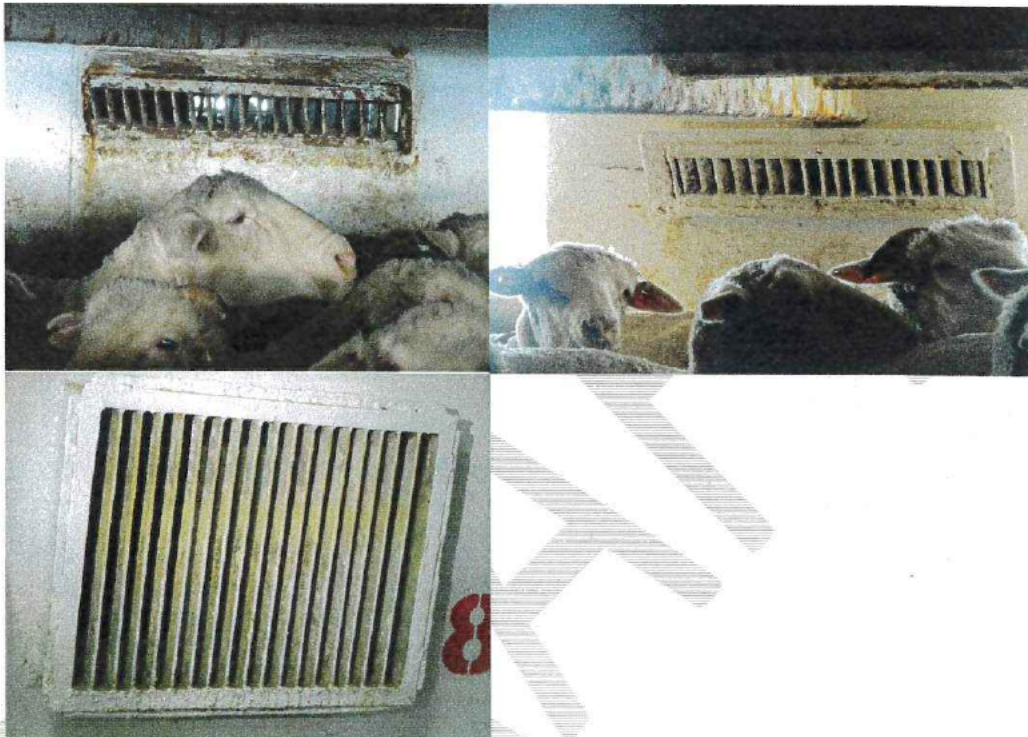
**Fig 2-4. Ventilation ducts have been recently enhanced with steel plates within to direct more airflow into the pens and towards the animals.**

implemented on the Maysora through the use of multiple mechanisms that have been tested by the company in consultation with AMSA. This included the use of mesh around the mushroom in vents to allow for more air flow through the ducts. He mentioned how simple changes like these had led to 4 times the increase in air volume into the vessel.

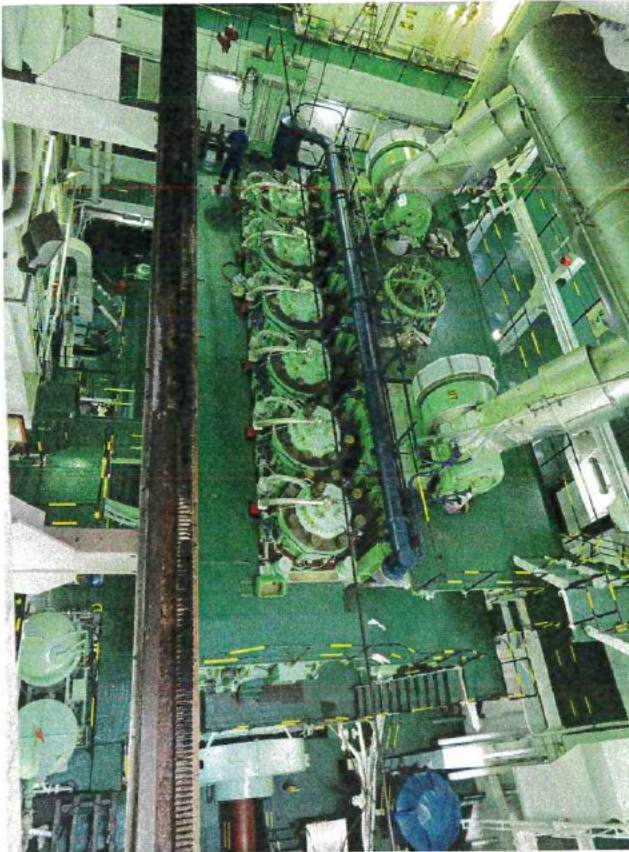
The engine is a **s. 47G(1)(a)** for the technically minded but suffice to say the engine and generator room is a very large scale operation (**s. 22(1)(a)(ii)** May 2018).

Fig 6. Engine room

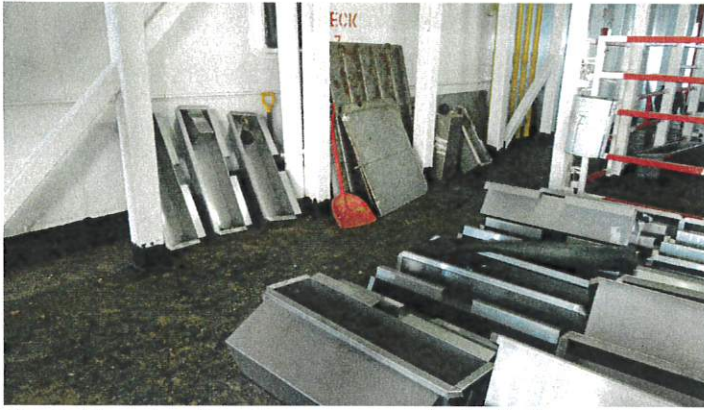
**Fig 9. New feed and water troughs built by technicians on-board during voyage 115**

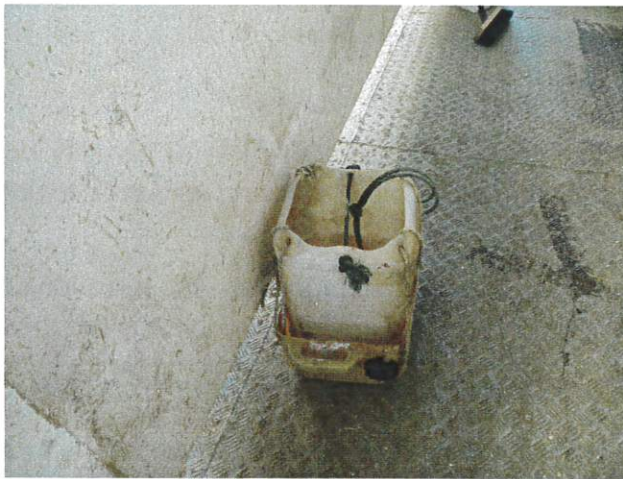
**Fig 10. Water from troughs are manually tipped onto buckets such as this and then poured down a drain instead of spillage into pens**
