**Independent Observer Report for
Voyage 161L
Aboard Livestock Carrier
MV AL MESSILAH**

FREMANTLE TO KUWAIT, PORT OF HAMAD AND JEBEL ALI
JUNE 6 TO JUNE 26, 2018

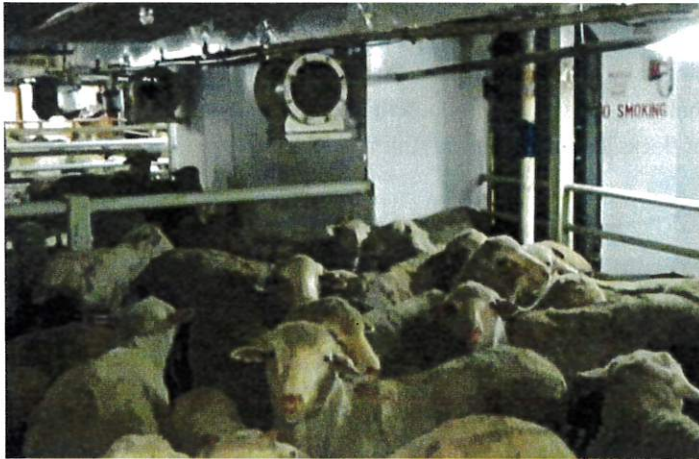
MVI_0744 Smaller End Fans

In addition to the integrated ventilation system there are fans installed overhead of the sheep to further circulate air within the deck spaces. Smaller fans are sited against walls to actively deflect airflow and other larger fans sited out from corners and along the greater headspace of the larger decks to redirect and enhance airflow. Six of these large fans had been procured following the previous voyage and these were installed during this voyage.

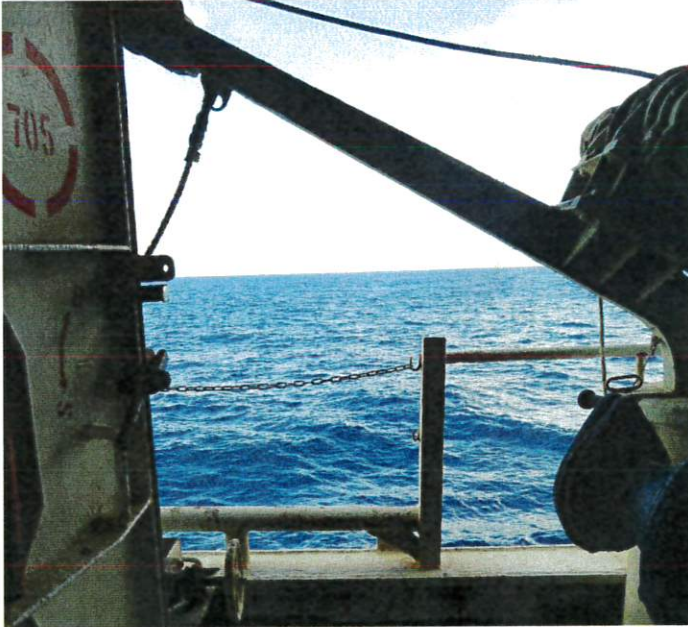
IMG_0367 Large Open Sea Doors

Decks 7 to 11 had various open access points of variable size ranging from the large sea doors either side on deck 7 through pedestrian doors to small half height viewing hatches. Additional ventilation hatches had also been made in the forward wall of decks 10 and 11 in the Animal House.

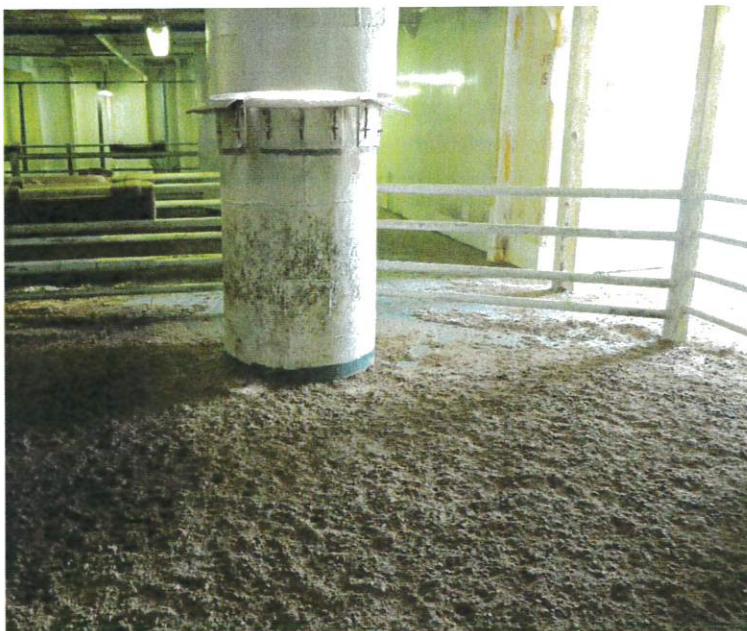
IMG_1581 Differential Drying of the Pad AFT Deck 9, In Pen Supply Vent and AFT Pedestrian Hatch on Right in Image

The functional impact of this complexity was evident in how the sheep distributed themselves within the confinement of each pen and around the available vents particularly when warmer more humid conditions were encountered in the Persian Gulf. It was also demonstrated by the differential drying pattern I observed when mapping the pads on vacated decks immediately following the offload in Kuwait. Pens in the AFT areas of Deck 9, 10 and 11 close to the pedestrian hatches had consistently dry pads and more than elsewhere the pad material migrated out of the pens to be swept up and discarded by the crew. The example in IMG 1581 shows the impact of the ventilation through the pedestrian hatch in drying up pad moisture caused by trough spillage after offload.

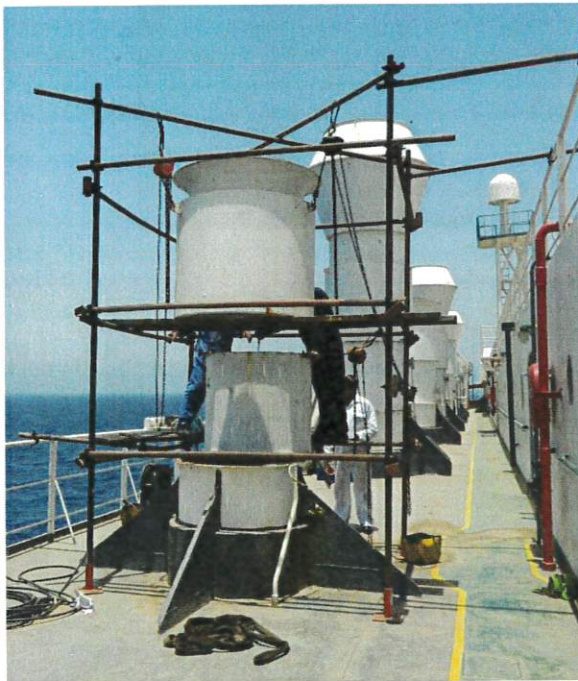
IMG_1722 Ventilation Shaft Maintenance

Immediately following off load the crew set began routine maintenance activities including to the ventilation turret in IMG_1722. At the end of the voyage I observed changes to supply vent S6.2 on deck 2 and was told that a comprehensive program of vent adjustments was being undertaken following recommendations from a German Ventilation Consultant.

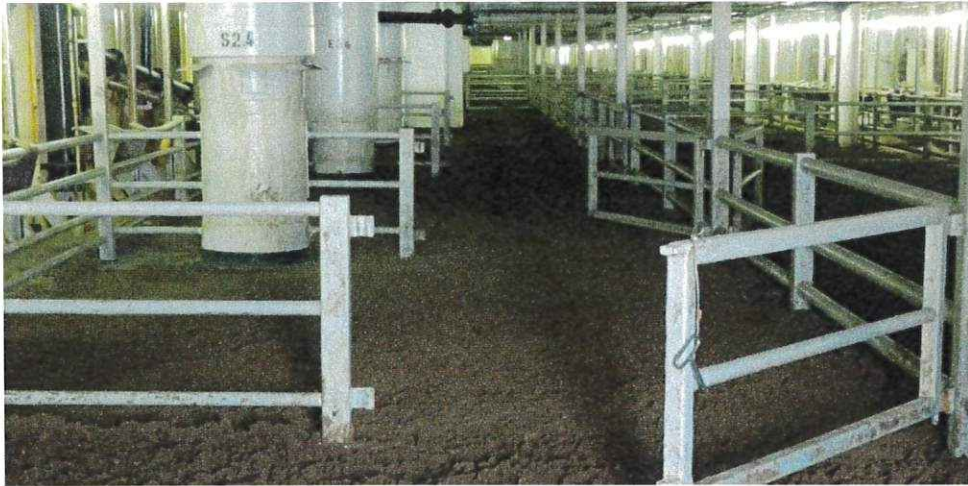
IMG_1589 Column Formation of the Pens Constructed with Pipe Rail Fencing

The pens are variable in size, and sometimes shape, fitting into a three column array with two side by side pens in each column (A&B, C&D, E&F) separated by two laneways extending the length of each deck. Somewhat irregular cross laneways provide access points to each column of pens which are filled and emptied via gates between adjacent pens.

The pipe rail fencing where no troughs were attached was observed to be essentially porous to adventurous lambs and smaller sheep with significant numbers wandering freely in the laneways and seen to jump through fences when driven at offloading. Gates between adjacent pens in each column were often left open to allow sheep of the same class to further distribute within the available space.

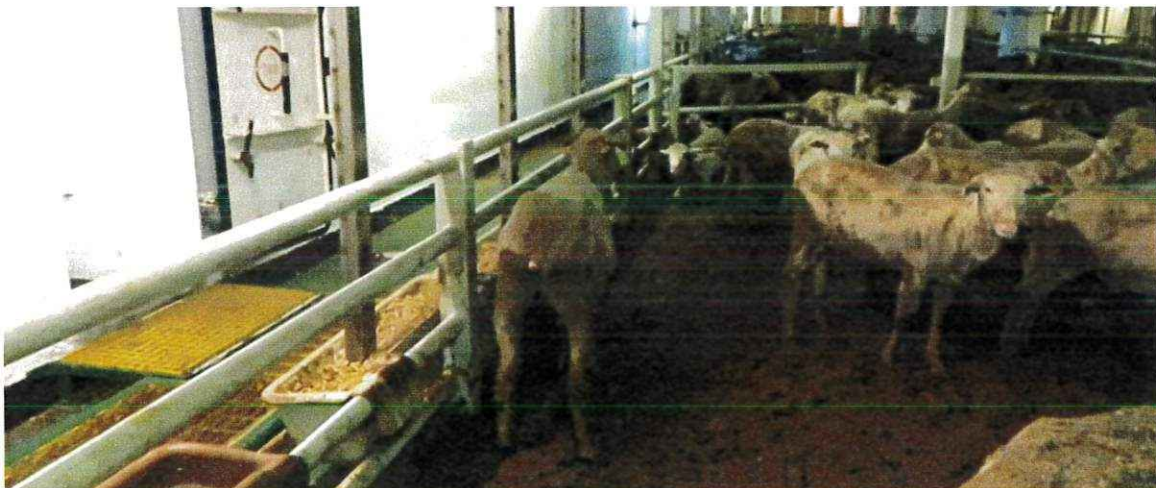
MVI_0778 B Pens Separated from Engine room by Laneway

The pen distribution in column C&D is disrupted by the presence of the engine room. Some of these pens abut the detectably warm walls of the engine room and on Deck 8 a large space is devoid of pens to accommodate a more pronounced floor temperature gradient coming away from the engine facility. B and E pens lateral to the engine room are separated from it by the width of the laneways however a consistent air temperature gradient was observable here also. I collected surface temperature data to examine the effect of the heat emitted by engine room and observed the sheep penned adjacent to it. I was unable to observe any significant negative effect. In fact to some extent it seemed to be the opposite particularly in areas with increased air movement and I was left wondering if the engine warmth has a localized drying effect that improves the conditions in the affected pens.

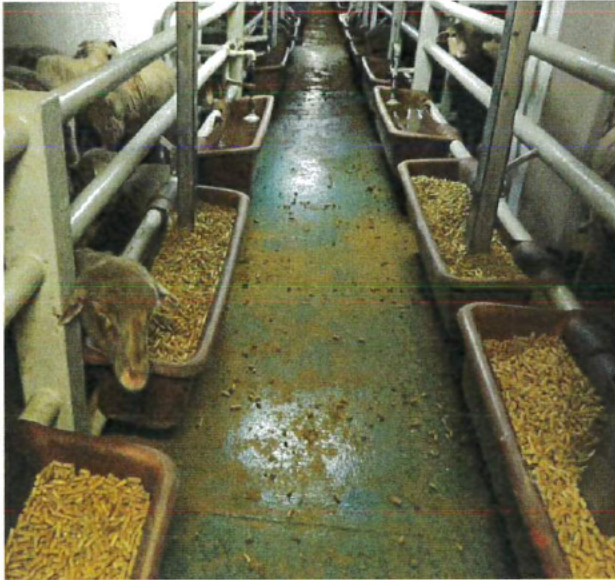
IMG_0055 Feed and Water Troughs

Pens were well serviced by water and feed troughs with the majority having at least two of each and most more than two of either. A small number of pens in the aft section of decks 9 and 10 had only one water with two feed troughs or one feed trough with two water troughs. The set-up of these pens seemed to be limited by the available fence space upon which troughs could be attached.

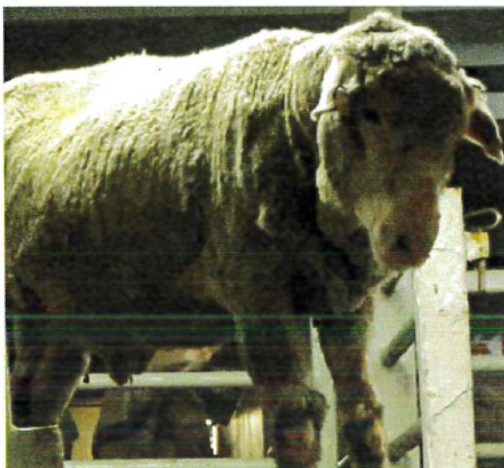
MVI_0385 Abraded Knees of a Free Ranging Wether Day 5

The deck floors in the animal house are rough painted decking that provides a nonslip but abrasive surface as evident in IMG showing the knees of a free ranging wether on Day 5. For contrast IMG 2035 shows a lamb penned on a pad, Day 19.

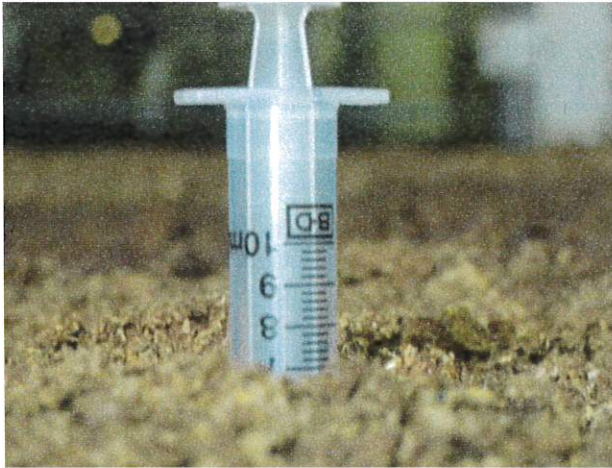
IMG_1561 Mapped Deck 9 with Typical Pad Depth Day 16

I mapped deck 9 after it was completely vacated through offload in Kuwait. I found this valuable in identifying the pad depth range described above and understanding the predominant nature of typical pad material as in the following images. This material had minimal odor and was similar in appearance to dry aged cow pat.

There appeared to be an inverse correlation of pad depth to pad wetness with thinner pads, such as the one in IMG 1563, being the wettest and more textured without the smoother dry crusted surface of the pad in IMG 1561.

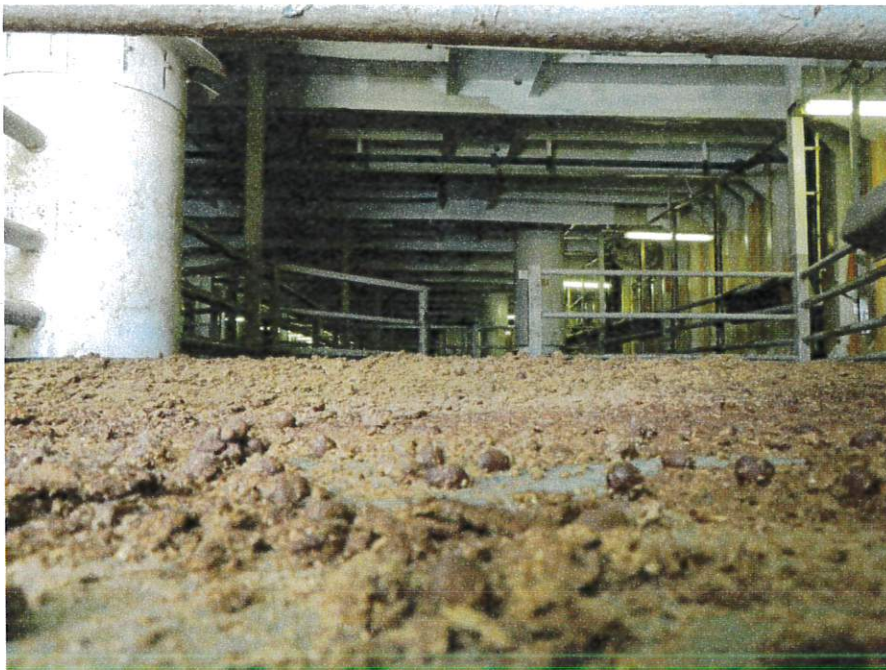
IMG_1559 View from Fence Line with Bare Deck Showing through to Slightly Mounded Area Central in Pen

The pad of manure admixed with some spilt fodder provided for sheep bedding as it built up from the bare deck at loading to a variably thick 5-12 cm dry to moist layer at the time of offloading.

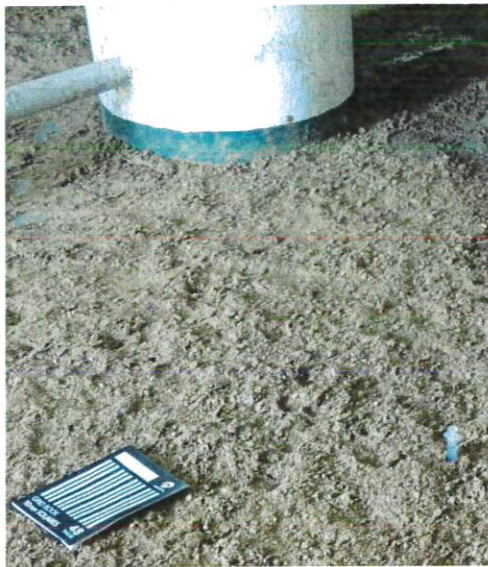
IMG_1564 Depth of Pad Deck 9 Day 16

In IMG 1564 the level of green paint at the base of the supply shaft further verifies the pad thickness measured on Deck 9, Day 16.

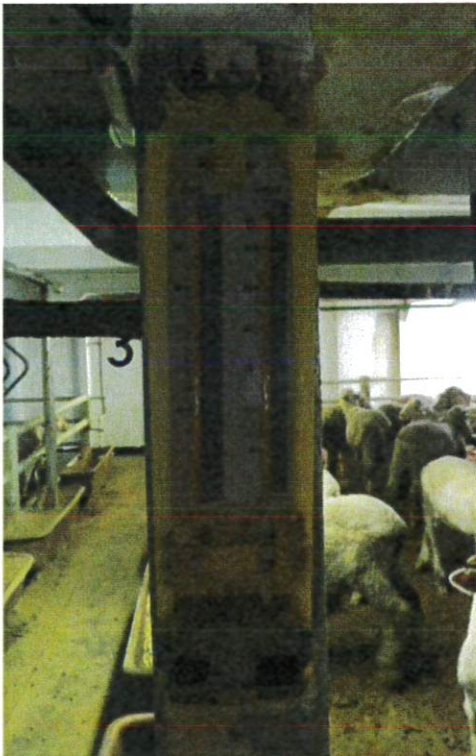
IMG_0812 Thermometer Deck 3 Forward

however there is much variability in their set up and the ease at which they can be read. The thermometer on forward Deck 3 (IMG 0812) was the most difficult to read because of mercury filling, poor lighting and because it could not be removed to facilitate reading. This thermometer was mounted bare onto the upright however others were mounted within a wooden box surround. The effect of the varied setups is unknown however the critical nature of temperature and humidity assessment to the management of livestock that are at risk of heat stress should mandate the capacity for increased and better quality surveillance.

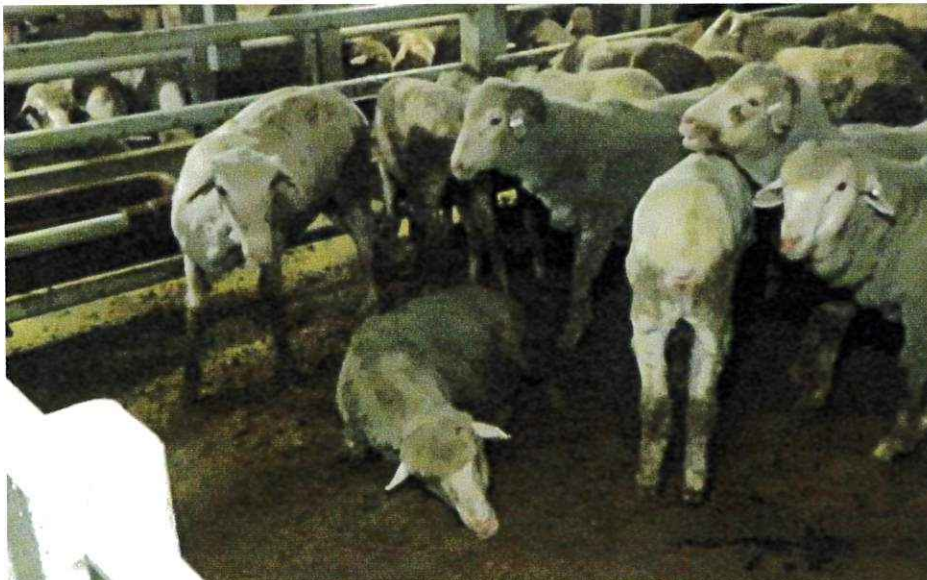
MVI_0430 Single Sheep Showing Increased Respiration and Open Mouthed Breathing

The relationship between ambient temperature (based on readings from the available thermometers) and signs of increase respiratory effort/stress did not emerge as clear cut to me. Early in the voyage when the temperature and humidity conditions were comfortable small numbers of sheep were seen to have increase respiratory rates with periodically lip licking and slightly open mouths. Single sheep such as in MVI 0430 show apparent respiratory stress.

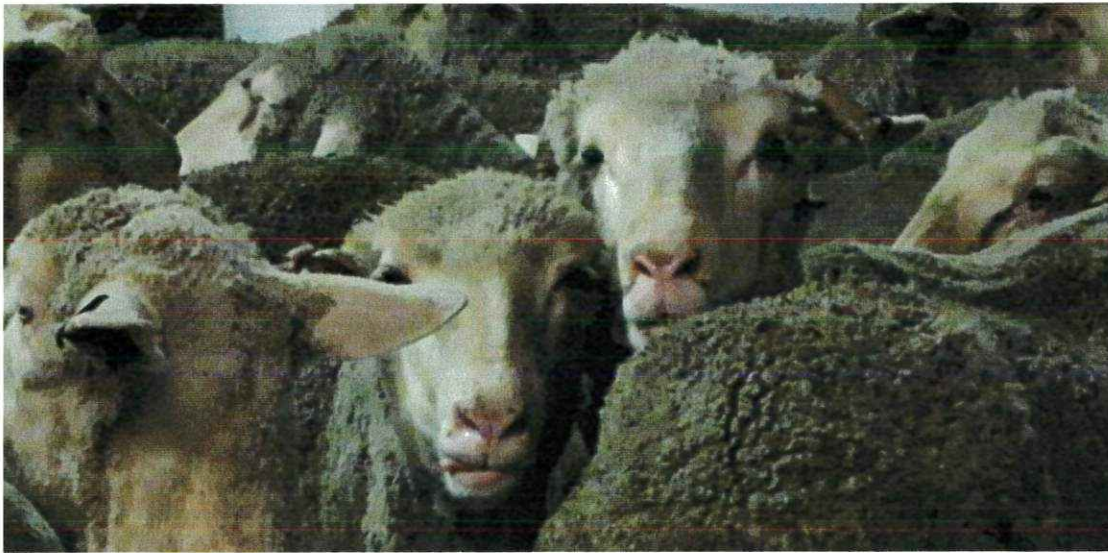
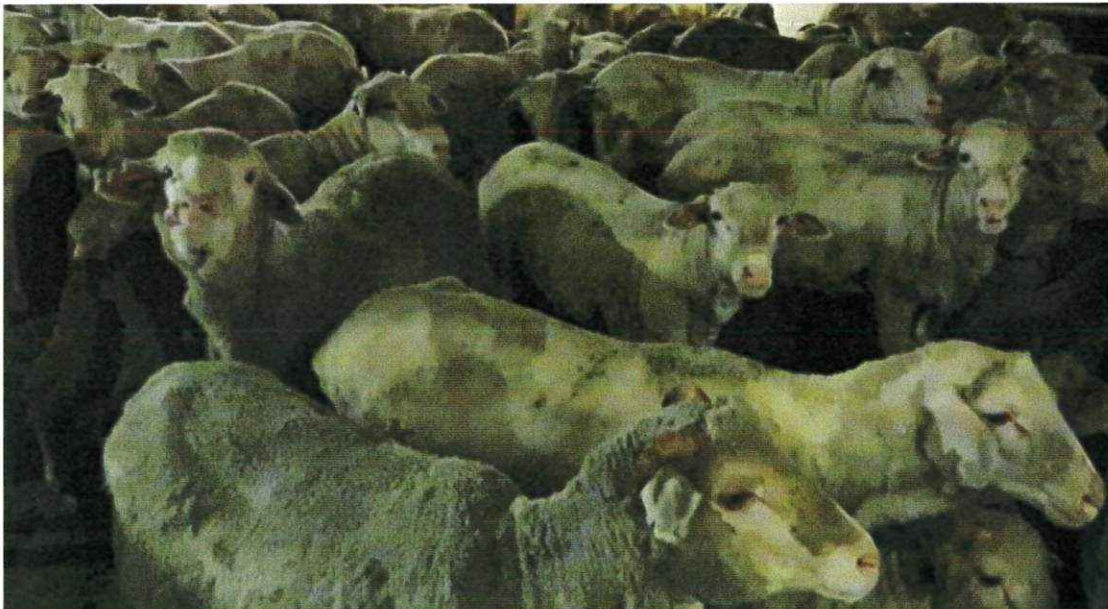
When the dry bulb temperature increased to around 32-22 degrees Celsius and the wet bulb was also high around 29-30 degrees Celsius a greater percentage of the sheep showed the slightly open mouth breathing and lip licking in MVI 0862 and MVI 0584.

MVI_0862 Earliest Signs Were a Slightly Open Mouth and Lip Licking

MVI_0584 Lip Licking and Variable Numbers of Sheep with Slightly Open Mouths

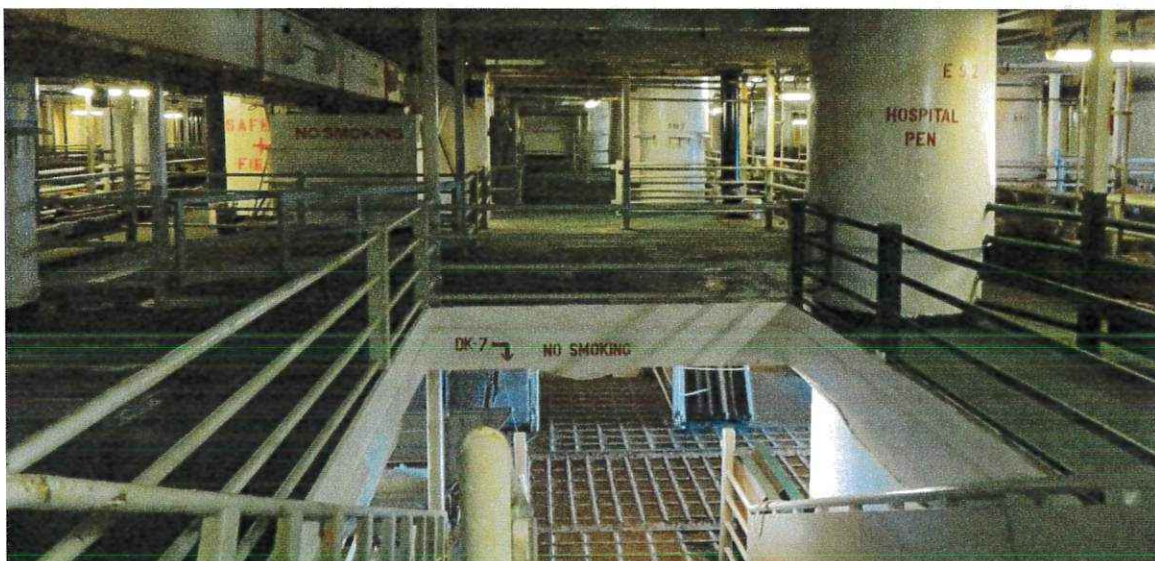
IMG_0059 Empty Space on Deck 8 at Time of Departure

The Load Plan recorded the total final number of sheep loaded as 57428 head and 104 cattle which was 7906 less head of sheep and 124 less cattle than the previous similar voyage and was well within the requisite ASEL plus 17.5% additional space. A large area of deck 8 seen in IMG 0059 was vacant at the time the vessel set sail.

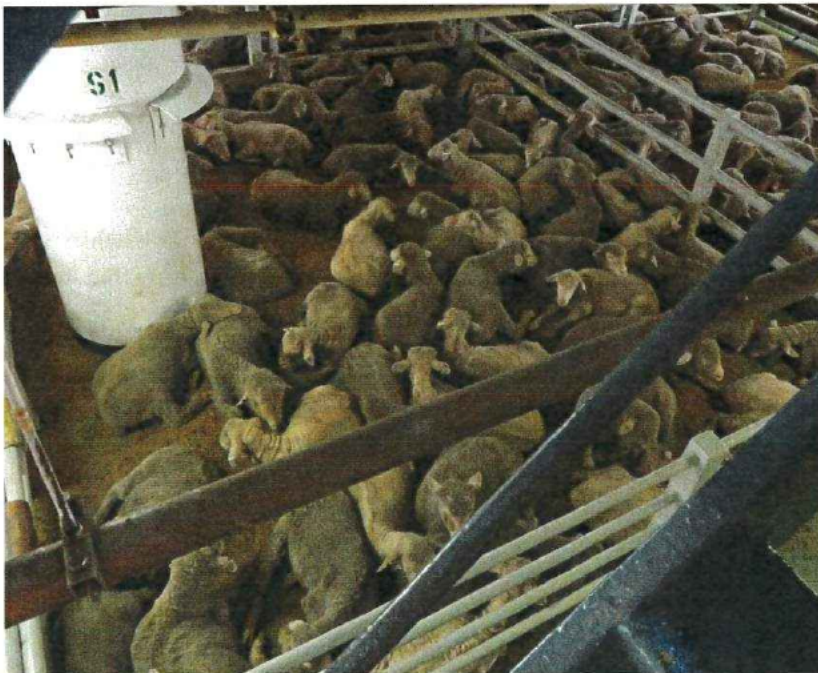
IMG_0073 Sheep at Rest Unaware of My Approach and Representative of Stocking Density

I observed nothing that concerned me with respect to stocking density with at least greater than half of the stock in any pen able to be recumbent at any one time. As the voyage progressed I observed more sheep remaining recumbent as I passed by and very often nearly all the sheep, except those at the troughs, would be recumbent. Post redistribution the pens of the larger sheep appeared relatively empty and those with lambs relatively more stocked which s. 47F(1) explained was a consequence of the revised requirements based on average weight per unit area rather than head count.
